Rainforest Reserve and Arch Cape Forest
Ecological Road Assessment

Completed by Springboard Forestry LLC
Client: North Coast Land Conservancy
7/7/2023

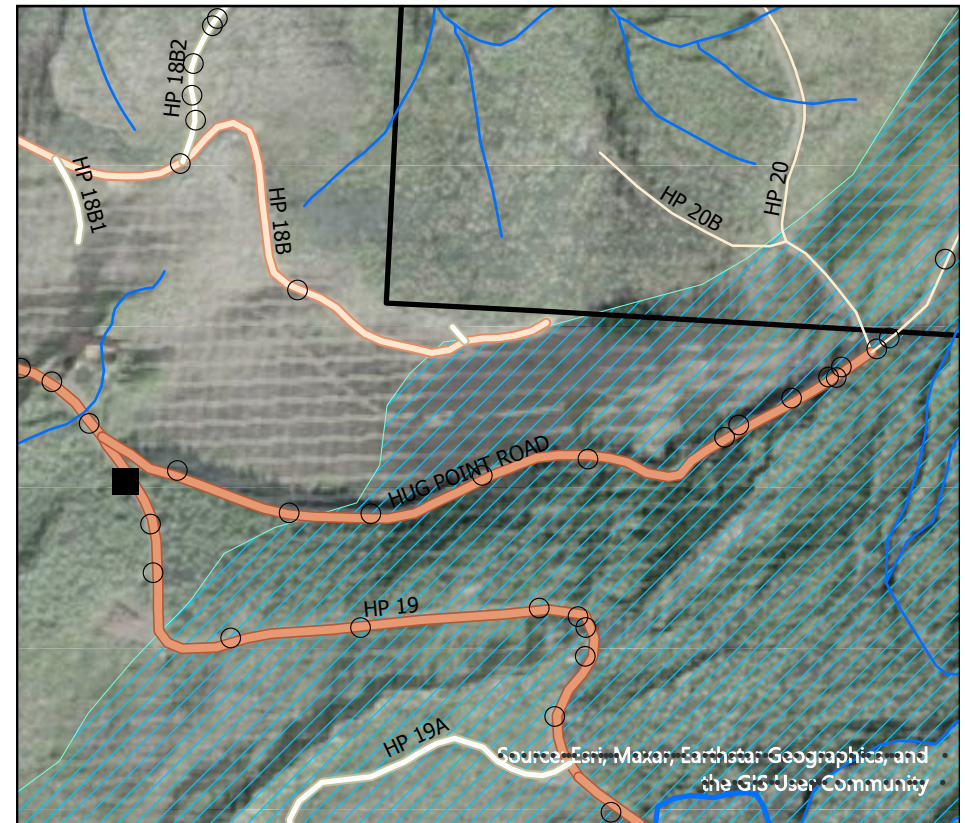
Segment 9

The Hug Point Mainline past the HP 19, only providing access to a small area of the ACF, to Lewis and Clark Timberlands, to the HP23 (which dead-ends on the ACF) and eventually to the Onion Peak Rd. The road is well surfaced with some brush growth. In the middle of this segment is a large slump that shows continued evidence of down-slope movement. The slump is approximately 150' long and is the result of multiple springs in the slope feeding a culvert that was perched approximately 3' above the bottom of a settling pond. This saturated the fill and caused the road failure. In addition, the segment needs 2 additional culverts added, culverts, re-opened, ditches re-established, and minor grading.

Management Recommendations: The major fill failure on the Hug Point Road needs to be removed, a new 24" culvert installed, and new fill established. While the fill is saturated, this is primarily due to water flowing past

an 18" ditch relief culvert approximately 50' uphill from the failure. In addition, the segment needs 2 additional 18" culverts added, culverts re-opened, ditches re-established, and minor grading. Estimated cost for the large culvert replacement is \$15,000, due primarily to the large quantity of fill that will need to be end-hauled to another location. A rock source exists approximately 200' downhill from the slump on the N side of the Hug Point Road. Rock from this source may be clawed from the slope and utilized for the re-construction of the culvert.

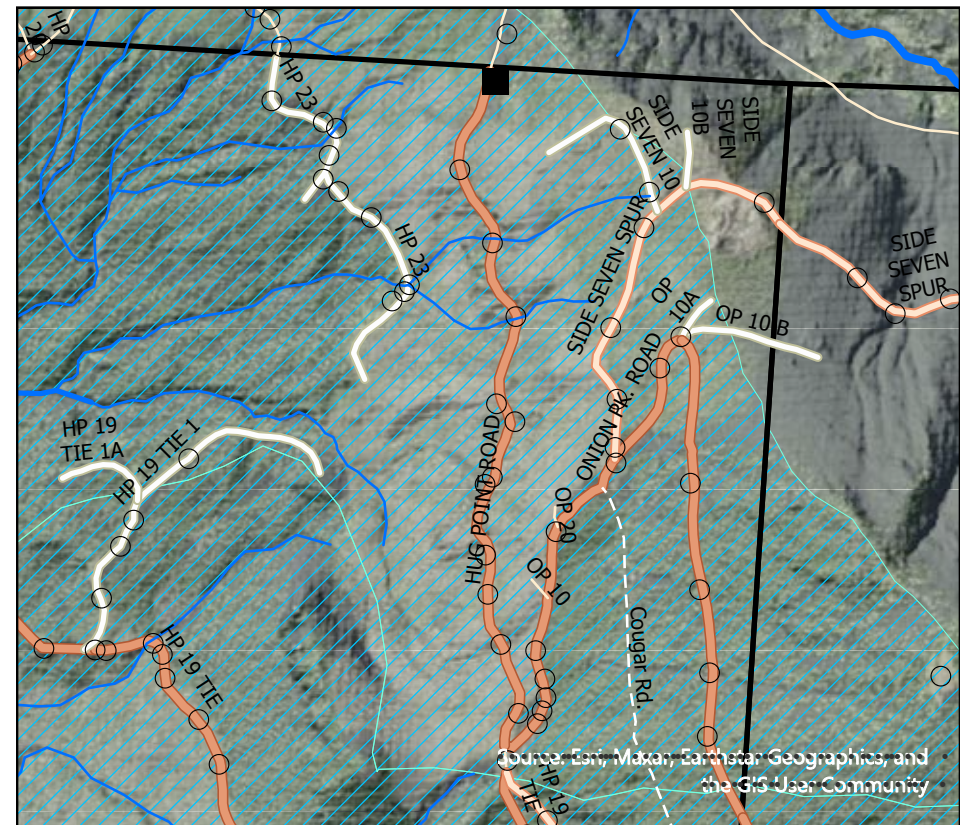
The Hug Point Mainline cuts mid-slope from Lewis and Clark Timber to the 4-way junction at Onion Peak Road. This road is currently closed, and has officially been closed for a number of years. Two landslides onto the road surface have temporarily closed it to all vehicle traffic. The road is built into an extremely steep slope with large areas of exposed basalt bedrock and large buried boulders. The rock is heavily fractured, leading to continued rock fall and erosion issues. In addition, this road cuts across the headwaters of Shark Creek. The entire area surrounding the road has been recently logged. Both the HP23 (below) and Onion Peak Rd (above) cut through this same stand and would allow access for fire, emergency, or forest stewardship activities. Based on the current ACF Multi-Resource Management Plan we do not anticipate active timber harvest occurring from Hug Point Road in this section, even if it were maintained. In addition to areas of rock fall onto

the road, two large slumps exist where the downhill road shoulder is actively eroding, there is at least one failed culvert, and additional culverts that are either partially obstructed or causing active down-slope erosion.

Management Recommendations: It is recommended to decommission and abandon the Hug Point Road from the property line with Lewis and Clark Timber to the intersection with the Onion Peak Rd. This decommission would include removal of all culverts, filling of the upslope ditch, excavation of the small areas of fill that do exist, and large water bars at 10' increments in all areas where the road bed allows for installation. In areas where the road is built on solid rock or large boulders, ditch filling and log placement in the road surface should force any ditch or road surface water downslope. Finally, the road surface should be covered with at least one "chunk" (a log at least 8' long and 12" diameter) every 50' and planted to native species. Areas with pooling water in the up-slope ditch that could provide invertebrate habitat should be marked and maintained. Large undriveable water bars should be installed at the junction with the Onion Peak Rd and either at the property line, or in agreement with Lewis and Clark, at the last turnaround on Lewis and Clark Timberlands (which are within the DWSA).

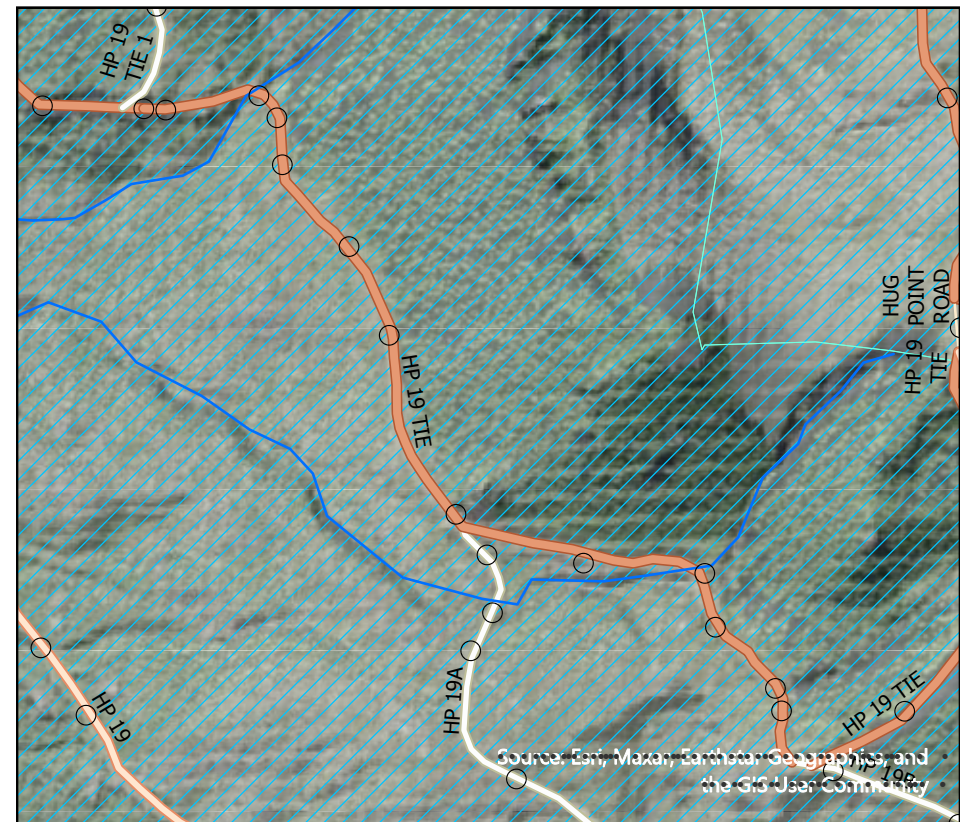
HP19 TIE continues up slope. As this point the surrounding geology transitions from relatively deep soil to exposed bedrock and large boulders with moderate slopes. The road is relatively steep and has numerous areas with a filled ditch and significant W shape road surface. This has begun to cause rutting and erosion with water running down the road surface. The road is built in places straight on bedrock and road base rock with no cut. These small segments out sloped with no ditch.

Management Recommendations: As this segment of road has gained a W shape and begins to experience erosion, it is in need of additional out-slope, ditch cleaning (where a ditch exists) and surfacing with 1.5" minus crushed rock. Due to erosion and the relatively steep road grade, the road base is exposed intermittently and grading would be insufficient to re-shape the road. Ideally, an excavator would re-shape the road

and recover as much material as possible from the shoulders. Following this, a traction coat of rock 2-4" thick would be applied followed by a water truck and compactor roller. This segment of road will be utilized regardless of whether a tie is built between HP23 and HP19 Tie1.

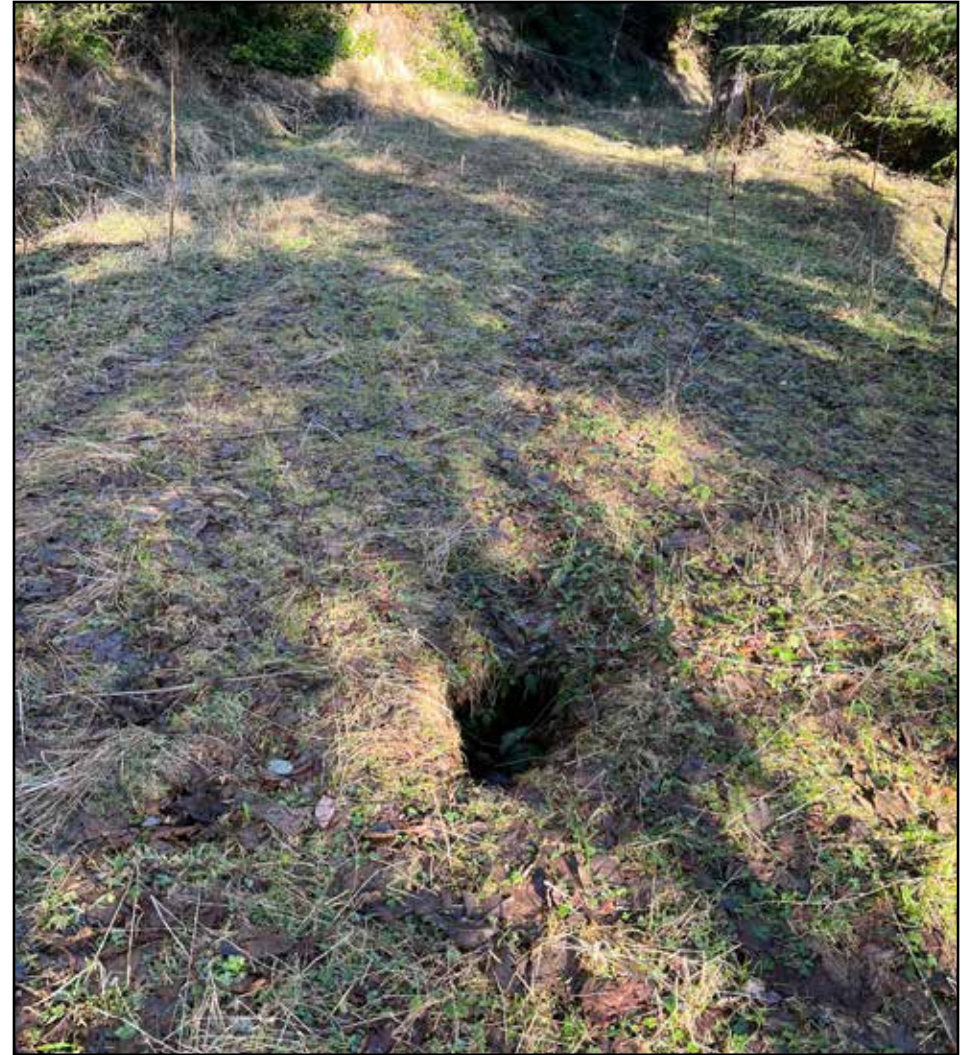
A failing log puncheon creating a hole in the road surface on the Onion Peak Rd. These holes are often very deep and indicate a hollow area under the road.

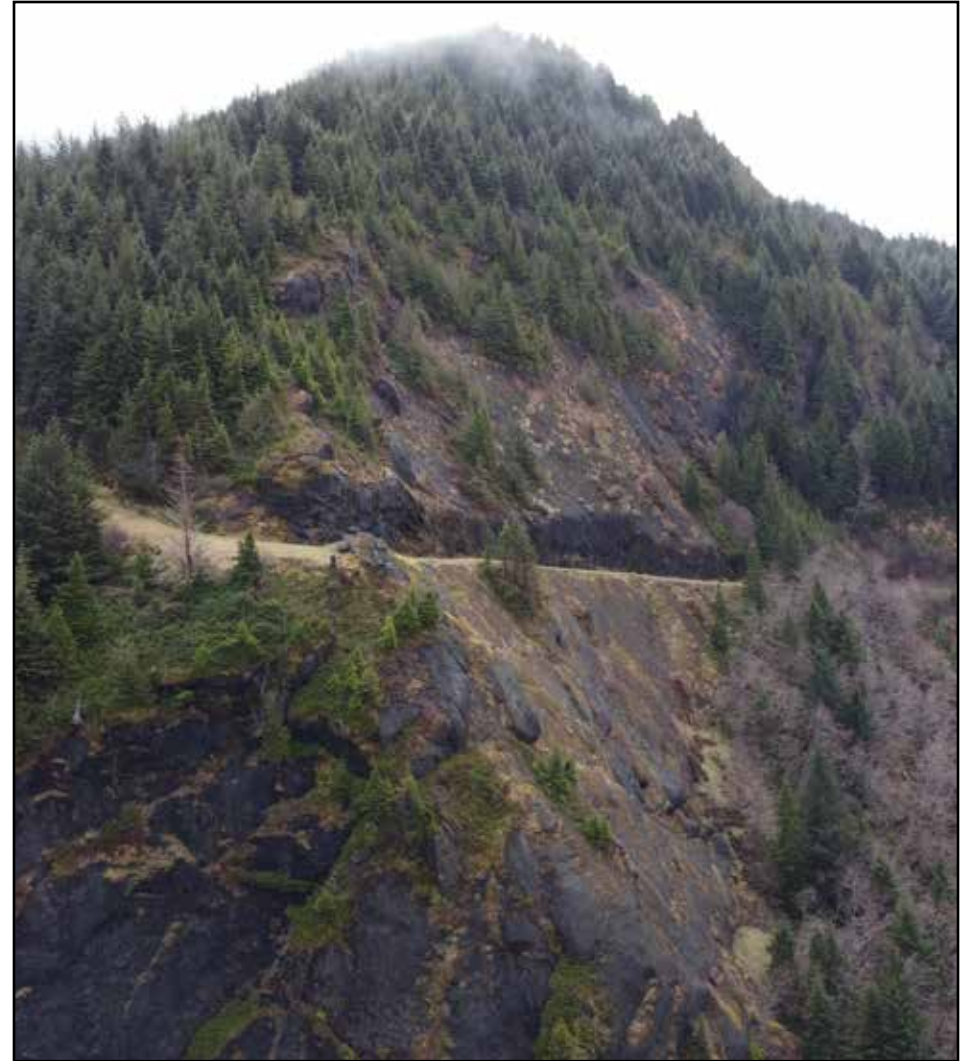
ABOVE: The Arch Cape Mill Road's impressive segment blasted into rock. The primary issue on this road is at the bottom, right side of this segment. A culvert and water bar have failed here and must be removed. In addition, all culverts above this should also be removed.
