ARCH CAPE SANITARY DISTRICT  
**BOARD OF DIRECTORS MEETING**  
Arch Cape Fire Hall 79729 Hwy 101  
Thursday March 16, 2023

ARCH CAPE SANITARY DISTRICT

# Wastewater Treatment Plant Facility Plan Update

November, 2022

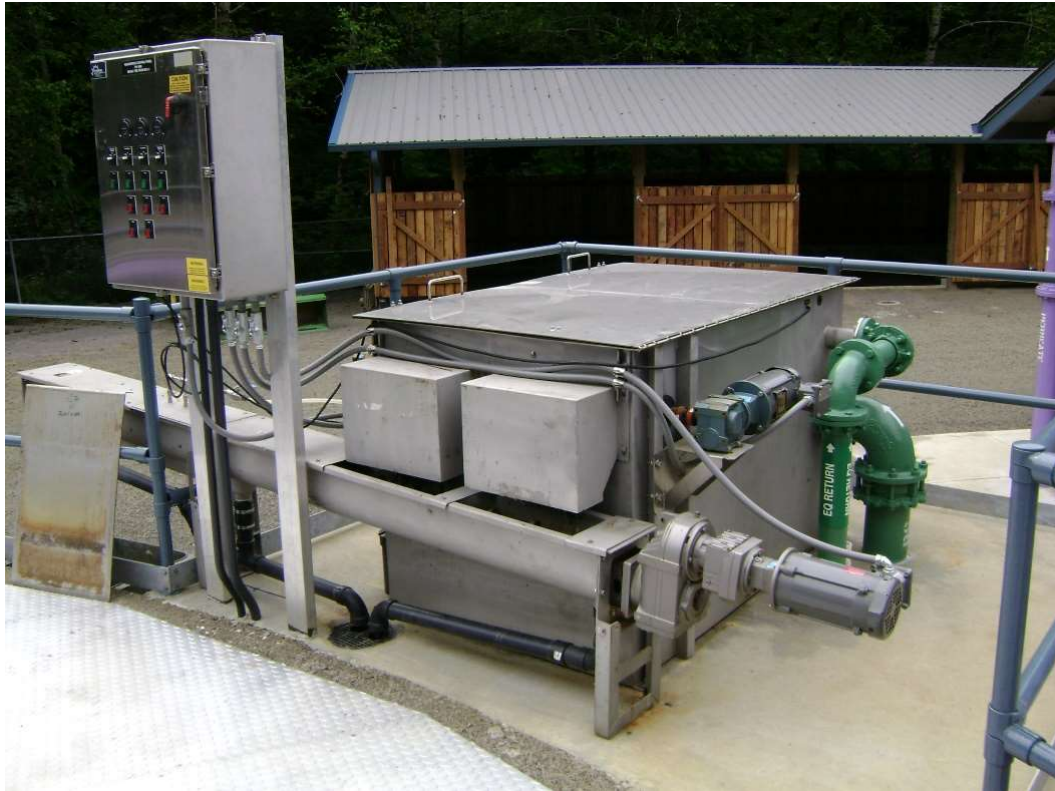
Headworks Raw Screening

The head works screening system consists of two 2 mm fine bar screens mounted in a common metal basin and a single compactor. Each screen has a peak flow capacity of 522 gpm (0.75 mgd). After the initial construction, a minor modification was made to the screenings discharge to prevent screenings from sloughing off into the screened effluent. Although old, the screening system does not appear to have any mechanical issues and is functioning as per the design.

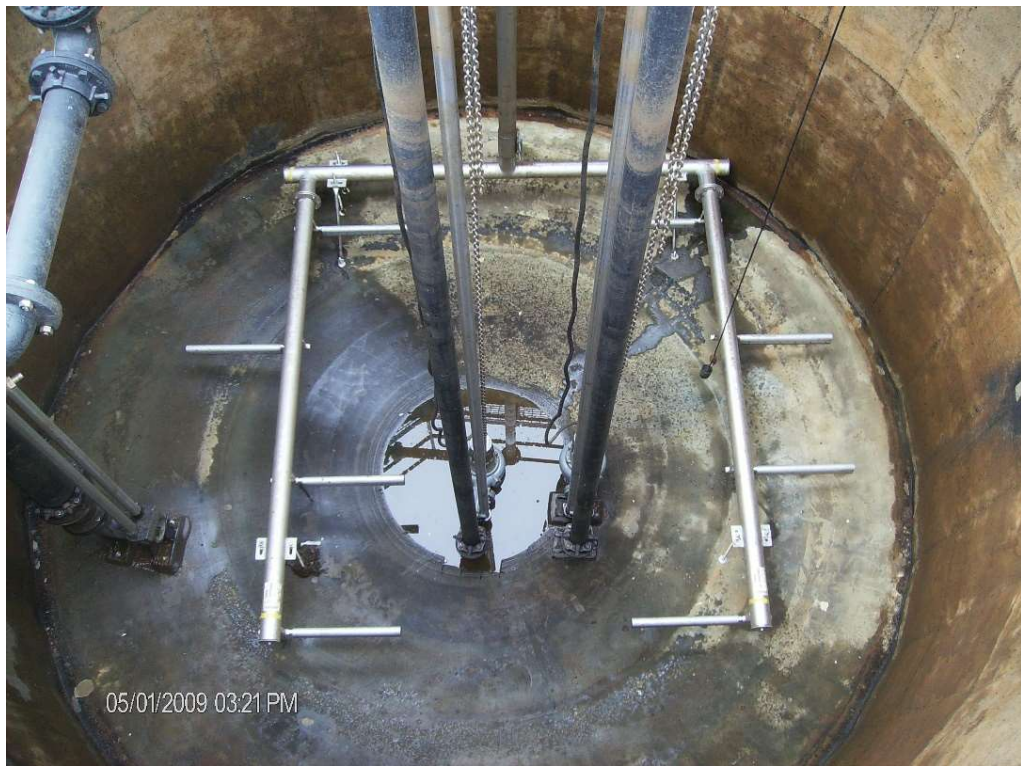
The Equalization Basin is designed to receive the overflow from the Anoxic Zone Basin during a high influent flow event. The basin has a volume of approximately 25,600 gallons and is aerated by a coarse bubble diffuser system. A 250 cfm variable speed blower provides air to the system. The basin has a detention time of 3.5 hours at the MMWWF<sub>5</sub>.

The contents of the basin can be pumped back to the headworks screen and returned to the Anoxic Zone Basin by one of two 127 gpm equalization pumps or by relocating one of the two Anoxic Zone Basin transfer pumps in the basin to discharge the contents directly to the MBR basins. There appears to be no operational deficiencies and the basin has functioned as intended during high flow events.

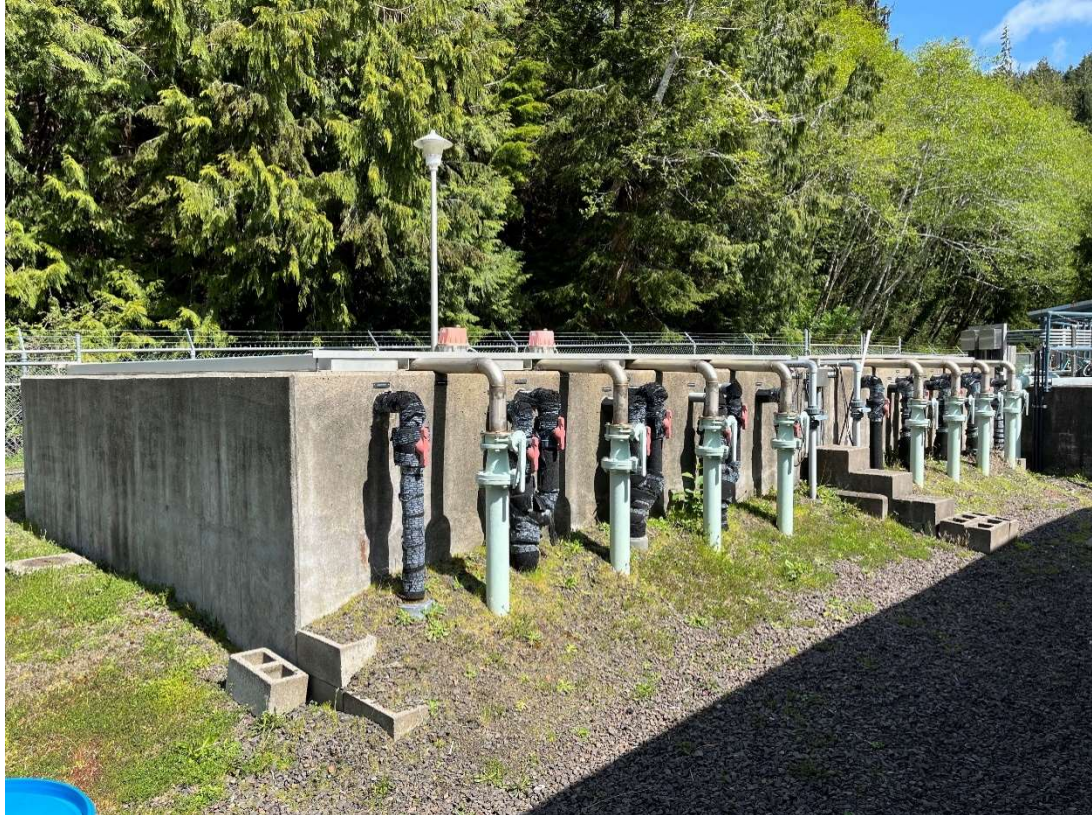
Membrane Filtration System

The MBR filtration system consist of two basins with a volume of 21,000 gallons per basin. The basins are aerated by one of two 40 hp 877 cfm blowers.

Permeate is pumped from the basins by two positive displacement pumps. Each pump has a maximum capacity of 525 gpm (0.75 mgd). In the event of a failure of one pump, a single pump can be used to pump permeate from both basins.

- 3 The PVC ball valves on the MBR permeate lines are beginning to have seal failures allowing vacuum leaks into the permeate pump suction. This introduces air into the permeate which imbalances the membrane loading and then impacts the disinfection sensors. Approximately 25% of the 16 existing valves appear to be failing. All valves should be replaced.

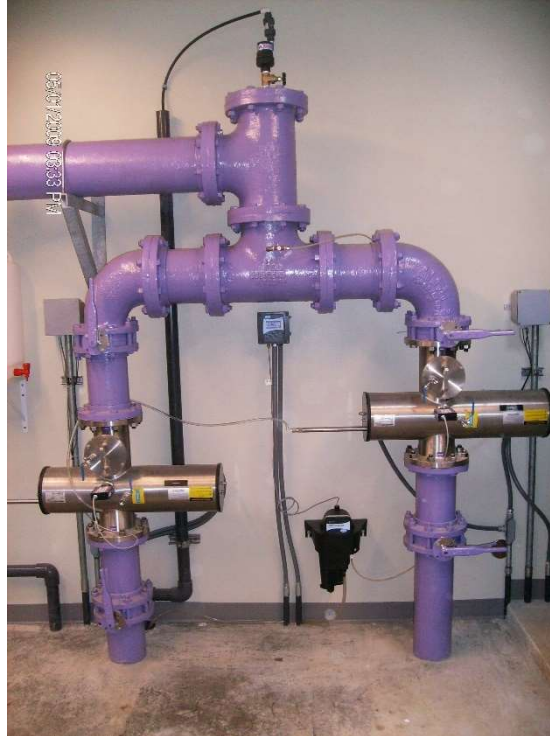
UV Disinfection System

The UV disinfection system consists of two closed vessel, medium pressure, high intensity systems with a design capacity of 0.72 mgd each. Flow is split between the two systems. Permeate is pumped through the vessels by the two permeate pumps. When there is no flow from the treatment system, a recirculation pump is called on to pump water back through the vessels to cool the lamps.

- 1 Both permeate pumps have motor and gearbox oil leaks that should be investigated and repaired to avoid potential damage.
- 2 The Aquionics UV Disinfection system appears to have multiple component failures. Water is draining from the internal vents which indicates multiple seal failures and likely associated corrosion of the operating components. Frequent lamp failures appear to be the result of deferred maintenance on the intensity sensing units indicating a false bulb failure alarm, and the automatic cleaning mechanisms. Both units have deteriorated to the point that a factory rehabilitation is mandated.

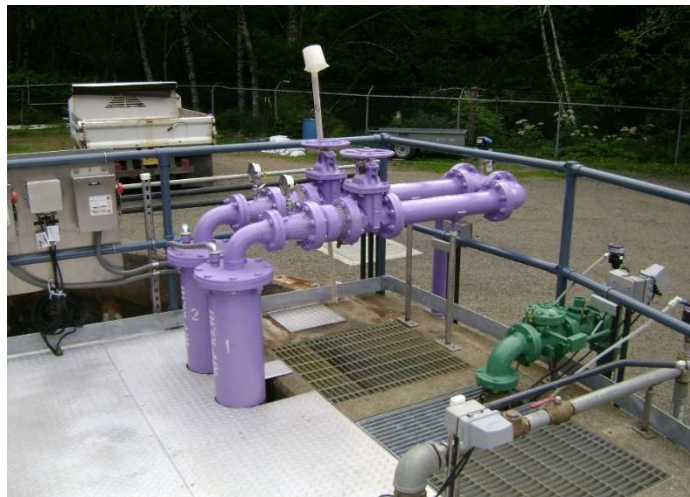
Reclaimed Water Pump Station

In accordance with the facility’s NPDES permit, discharge to Arch Cape Creek is prohibited from May 1 through October 31. During this time, the disinfected effluent is to be land-applied as recycled water. The recycled water system consists of two submersible turbine pumps with a capacity of 150 gpm (0.21 mgd) at 250 feet of head each. The pumps are located at the treatment plant in the reclaimed water basin along with the UV recirculation pump.

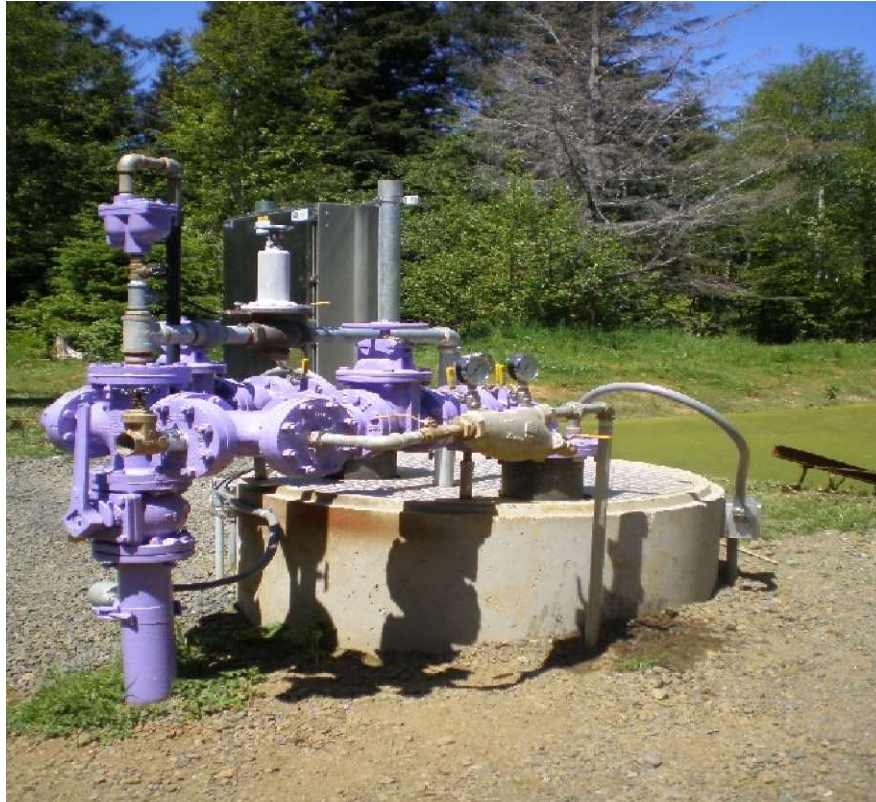
Irrigation Pump Station

The treated and disinfected effluent is pumped to an irrigation pond located offsite. An irrigation pump station is located adjacent to the pond and discharges effluent to a series of irrigation sets located in a wooded area east of the treatment plant site. The irrigation system is fully functional and does not appear to have any deficiencies. Pump capacity is adequate for the full buildout of the District.

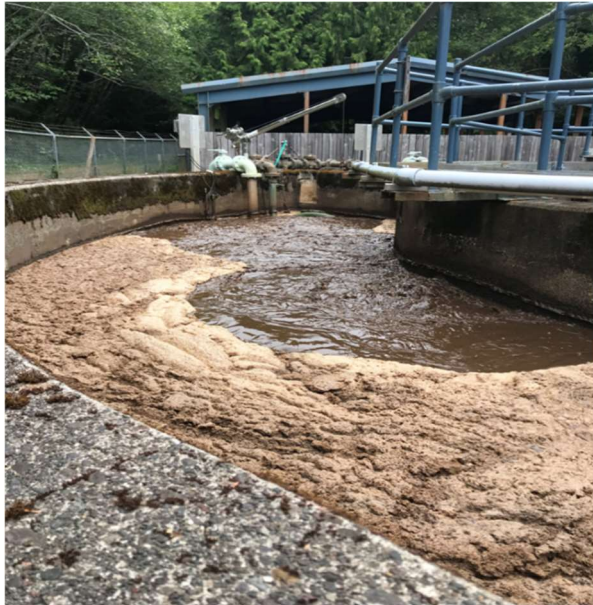
Aerobic Digester No. 1

Waste Activated Sludge is stored in two aerobic digester basins: a 25,400 gallon basin and 24,500 gallon basin. The basins are aerated by individual coarse air diffusers. A 20 hp blower can provide up to 250 SCFM of air to the basins. A 50 gpm submersible pump in each basin is used to transfer the basin contents to the sludge drying bed or wet sludge loadout. There are no known deficiencies associated with operation of the digesters.

- 3 All four blowers should have routine annual maintenance. Currently one digester blower has failed and is out of service and waiting for factory service for repair. To avoid premature failure, factory service should be scheduled annually or biannually as recommended.

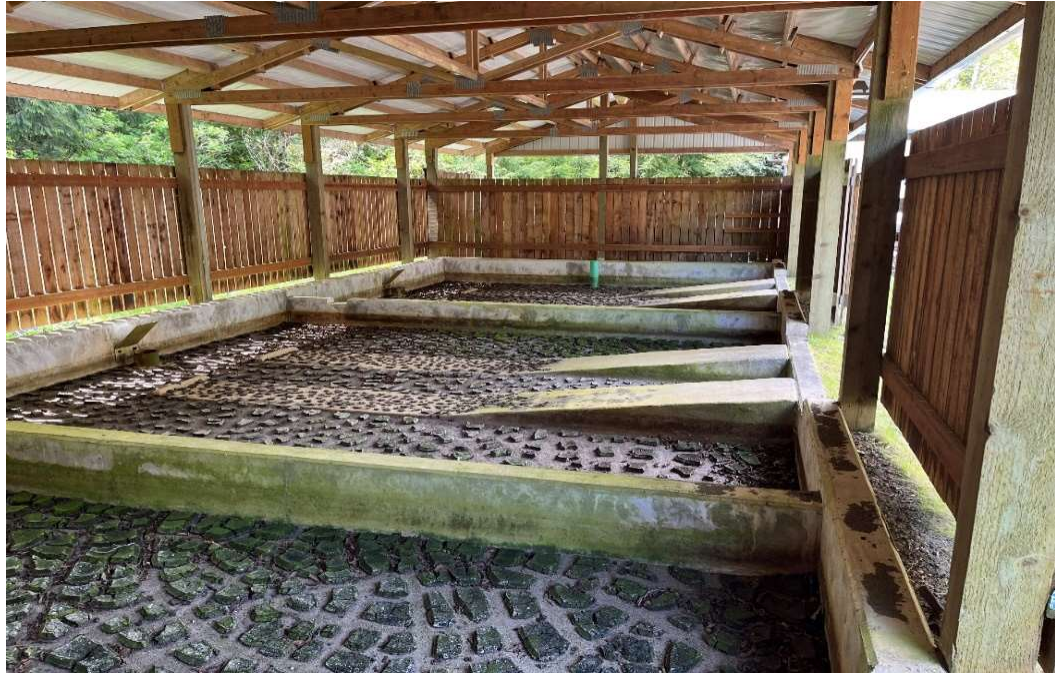
Sludge Drying Beds

The beds are capable of dewatering approximately 12,500 gallons per batch for a total of 90,000 to 100,000 gallons of 1.5 to 2% waste sludge per year. This process is labor-intensive, and disposal on the District's approved fields is more challenging each year. Although the District has sufficient land, concerns by neighboring properties and new regulations such as are contemplated with EPA's new action plan for per- and poly-fluoroalkyl substances (PFAS), make land application more challenging and costly each year.

Due to the waste sludge production, the drying beds must be operational year-round and loaded to their maximum capacity. Even loaded to the maximum, the drying beds have not been capable of processing the volume of sludge created for the past few years. The volume of waste sludge has increase by more than 12% per year for the past five years and totaled more than 135,000 gallons in 2021. The District has contacted with the City of Seaside to dispose of a portion of the liquid sludge for the past three years.

Sludge processing is the largest deficiency at the treatment facility. Although the drying beds can produce a well-dewatered biosolid, the capacity of the beds and the cost of in-house biosolids processing make continuing this current process less feasible. There is insufficient storage and in-house treatment is likely not the most cost effective option.

Waste sludge processing is recommended to continue the use of the drying beds, if desired, with excess flow delivered to the City of Seaside. Discontinuing the use of the drying beds entirely would only add a small increment in operating cost and would restore manpower capacity for the plant operators. Operators currently expend approximately 300 hours per year processing waste sludge. These manhours would be efficiently utilized in other system operations as the system grows.

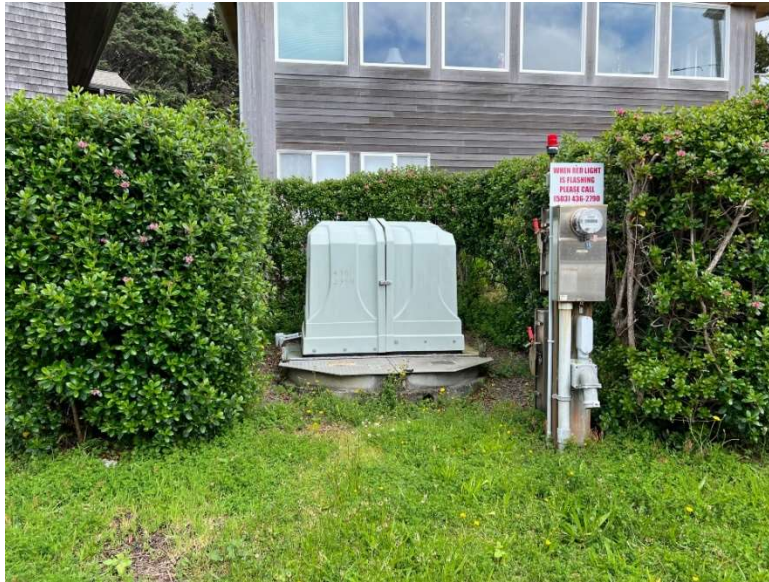
North Pump Station

The North pump station receives wastewater from the far north end of Arch Cape Sanitary District and serves and estimated 75 homes. According to literature provided by the District, the pump station consists of two 7½ Hp self-priming Smith & Loveless pumps, each with a design capacity of 200 gpm @ 60 feet of head. Flow is discharge

from the station through an 890 foot long 4 inch force main to manhole E-11 at the intersection of Larch Street and Pacific Road. The S & L packaged pump station is set over a 14.5 foot deep 6-foot diameter wet well.

A recent review of the pump runtime records for June through August 2021 shows the pumps are operating 1 hour per day or less during dry weather. Increased wet weather flows and storm events were noted to increase flows to the pump station. An example of the rainfall recorded between January 10<sup>th</sup> and 18<sup>th</sup> 2022 is shown in the following table where the run times increased to 22 hours or an average of approximately 3 hours per day.

There are no critical deficiencies associated with the operation of the pump station; however, it was installed in 2005 and is beginning to show signs of deterioration due to the coastal environment and is also reaching the end of its projected 20-year service life.

Both stations have a current design of 200 gpm. Both stations have adequate capacity to serve the District, however, the stations are 17 years old and will need to be replaced in the relatively near future.

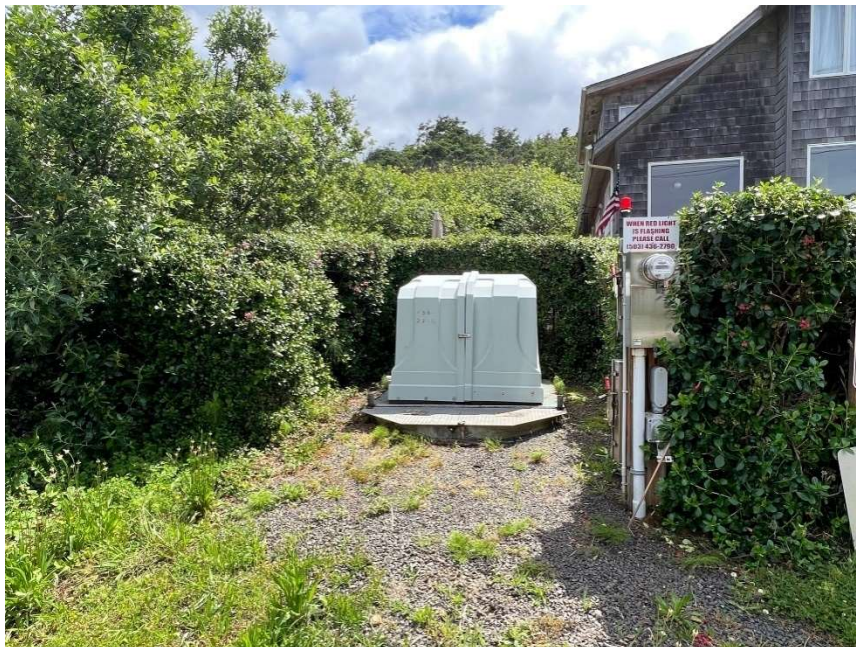
Asbury Pump Station

The Asbury pump station is located on Pacific Road just east of Asbury Creek. The pump station serves an estimated 68 homes. The pump station also receives flows from the North Pump Station. It is similar to the North station in that it is also an S & L station with the same design and performance: 200 gpm @ 60 feet. Flow is discharged from the pump station through a 380-foot long 4 inch force main to manhole C-3 at the intersection of Pacific Road and Shanks Avenue. The S & L packaged pump station is set over a 15 foot deep 6 foot diameter wet well.

Pump runtime records for June through August 2021 show that the pumps are operating 2 - 3 hours per day or less during dry weather. The January 10<sup>th</sup> through 18<sup>th</sup> 2022 timeframe was again reviewed. From January 10<sup>th</sup> to January 14<sup>th</sup>, the pump station ran a total of 68 hours or an average of 17 hours per day, and from January 14<sup>th</sup> to January 18<sup>th</sup>, it ran 34 hours or an average of 8.5 hours per day.

There are no critical deficiencies associated with the operation of the pump station; however, it was installed at the same time as the North end pump station and is also beginning to show signs of deterioration due to the coastal environment and is also reaching the end of its anticipated 20-year service life.

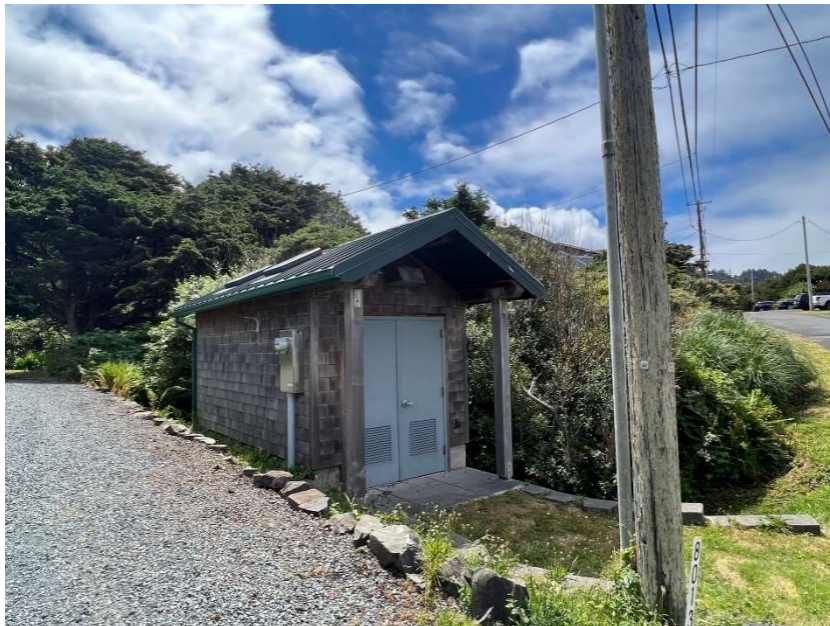
Sally's Alley Pump Station Control building

The Sally's Alley Pump Station is located at the intersection of Pacific Road and Sally's Alley. The pump station serves an estimated 41 homes and receives wastewater from the gravity collection system in the area as well as wastewater from the North End and Asbury pump stations. The pump station was rebuilt in 2015 as a submersible pump station with two 5 Hp pumps. Each pump has a design capacity of 220 gpm at 37' TDH. Flow is discharged from the wet well pumps through a 4 inch 320-foot-long force main to manhole A-21 at the intersection of Pacific Road and Montbrechia Lane.

Sally's Alley is the only station with remote telemetry. The telemetry system monitors several system parameters including wet well level and pump runtimes. This information should be useful in analyzing the existing performance and capacity of the pump station through a snapshot of the online data.

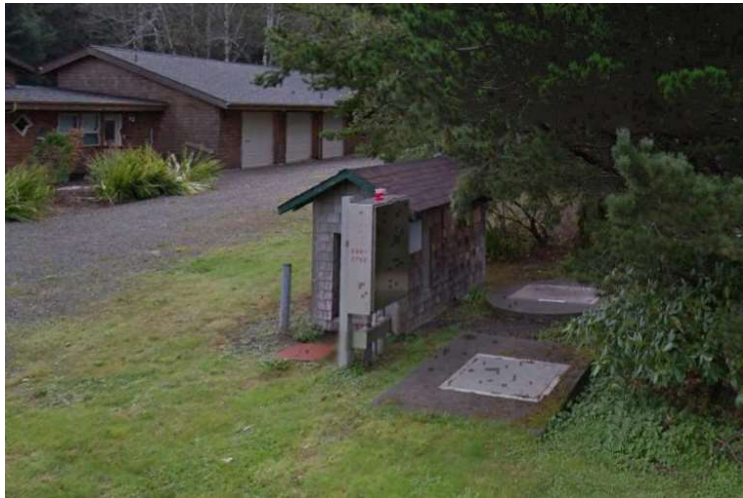
**Webb Avenue Pump Station**

The station consists of a wet well with duplex submersible pumps and a standby generator housed in a wooden structure. The pump station serves as the influent pump station to the District's wastewater treatment facility. Sewage is pumped to the WWTF headworks through a 6 inch diameter 2,150 foot long force main.

In 1999, the pump station equipment was rebuilt with new pumps, valving, piping, and control system. The submersible pump impellers were replaced in August 2014, increasing pump capacity to 300 gpm (0.432 mgd) using the available remaining pump horsepower without overloading the motor. With both pumps running, the pump station is capable of discharging 0.583 mgd (405 gpm) according to the District.

August 2021 runtime records show pump runtimes during dry weather of approximately 3 hours per day. January 10<sup>th</sup> through 14<sup>th</sup> 2022 runtimes totaled 79 hours over the 4-day period or an average of 20 hours per day. From January 14<sup>th</sup> through the 18<sup>th</sup>, a total of 48 hours were recorded with an average run time of 12 hours per day. In total, the pump station ran a total of 158 hours over an 8-day period with an average run time of 15.9 hours.

DMR records show daily average wet weather flows from the pump station to the treatment plant increased over a 5-year period from 0.134 mgd to 0.176 mgd (122 gpm). In addition, the peak day flow increased from 0.372 mgd to 0.55 mgd (382 gpm) in November of 2021 and 0.53 mgd (368 gpm) in January of 2022, requiring both pumps to be in service to meet flow to the pump station. This demonstrates that existing reliable pump capacity is inadequate to meet existing or future flows with additional development in the District.
