Rainforest Reserve and Arch Cape Forest
Ecological Road Assessment

Completed by Springboard Forestry LLC
Client: North Coast Land Conservancy
7/7/2023

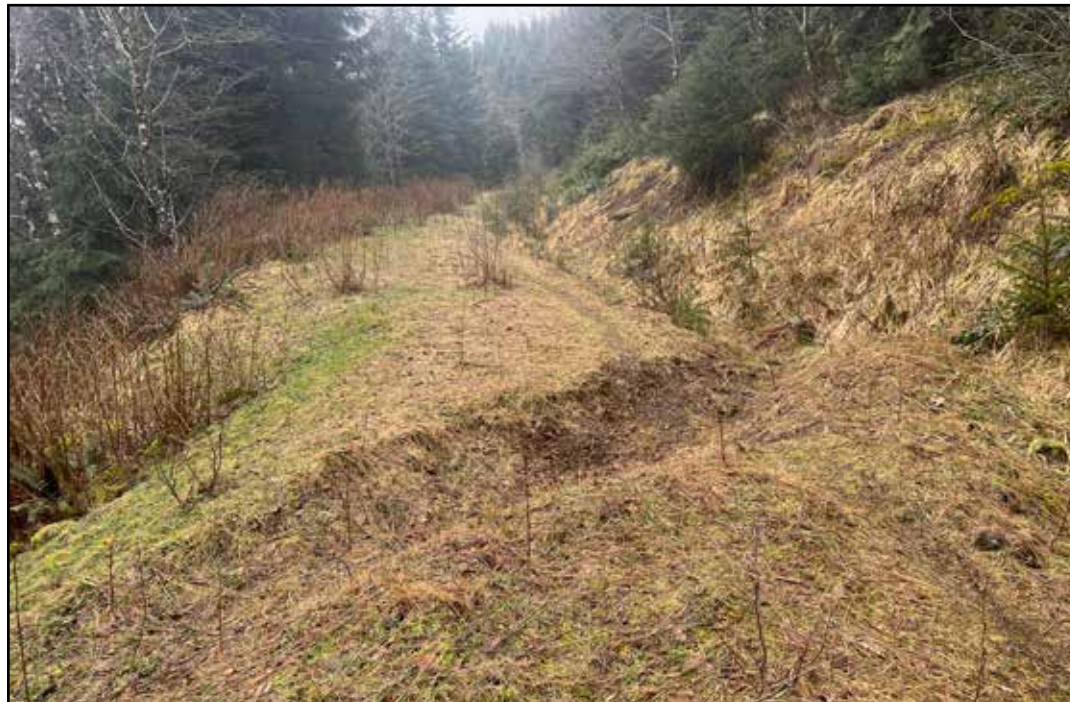
Water-Bar: A water bar is a groove or small (2" - 24") dip cut laterally across the road surface. Water bars should not be used for ditch relief, but are suitable for draining water off of a road surface. A large water bar that has accelerated erosion is shown below.

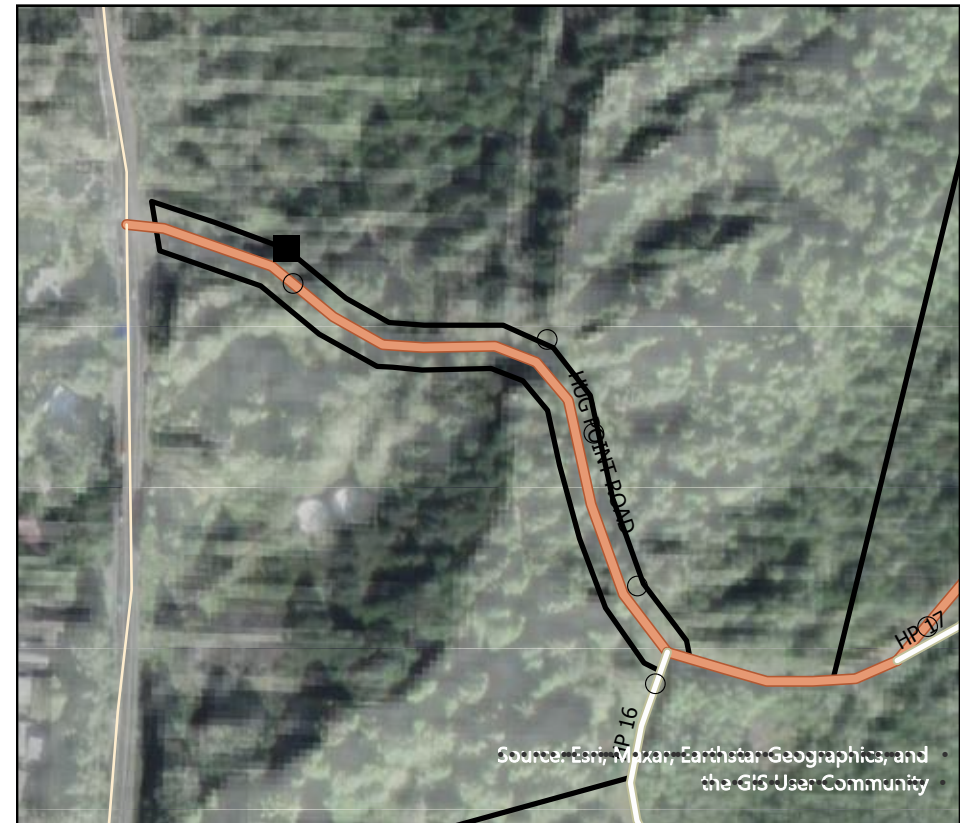
The Hug Point road is the primary access to both the Arch Cape Forest and Rainforest Reserve. This is an in-sloped road with a slight W profile. The ditches are vegetated and intact with multiple culverts. A water line and multiple fenced water system components exist along the road. A water line appears to run in the north-side ditch where two valve access boxes are marked with blue paint and carsonite markers. A property kiosk just inside the gate has not been maintained or updated as of spring 2023. The gate and pull-out are well maintained and heavily used.

Management Recommendations: Culverts should be cleared, being careful to not damage buried water system components. Road should receive light grading to re-establish crown and remove roadside berms. Brushing planned summer 2023.

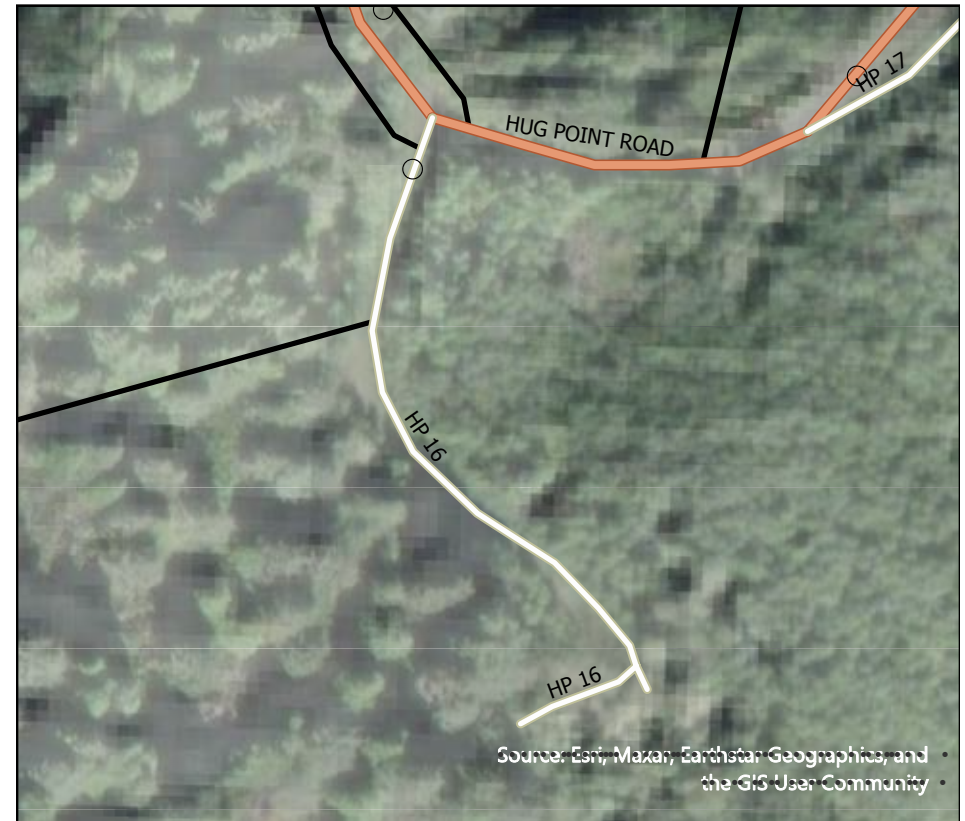
HP16 is the first short spur to the S of the Hug Point Mainline. This is a short spur with no culverts, fully grown in with blackberries and alder. This spur appears to have a rock base with significant vegetation growth. The road crown and ditch are intact, and carry no water. The road could be re-opened in the future if needed.

Management Recommendations: The road is slowly decommissioning itself due to lack of maintenance. Continued abandonment has minimal risk and no downsides. Recommendation is to not maintain the road unless needed for future management activities.

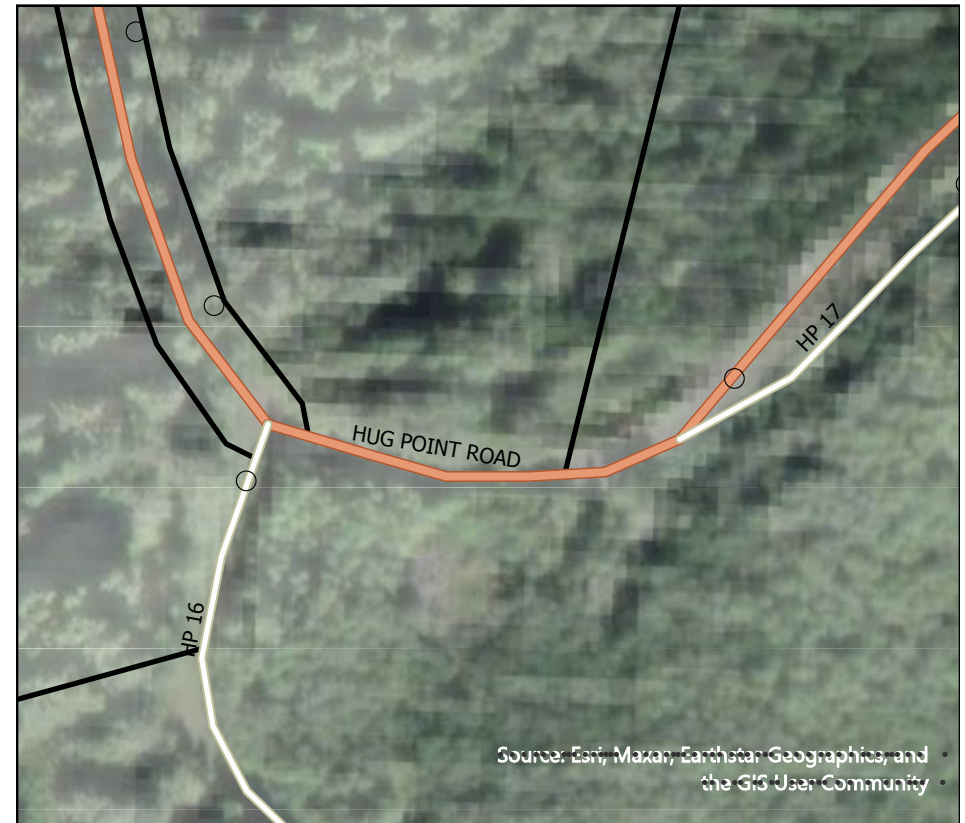
The Hug Point Mainline continues as the primary property access. The road is well surfaced with some brush growth. The ditch is vegetated and has some siltation. Culverts are choked by vegetation and the down-slope shoulder has a slight hump.

Management Recommendations: The road requires grading and ditch re-establishment. Ditches could be re-established with a small excavator.

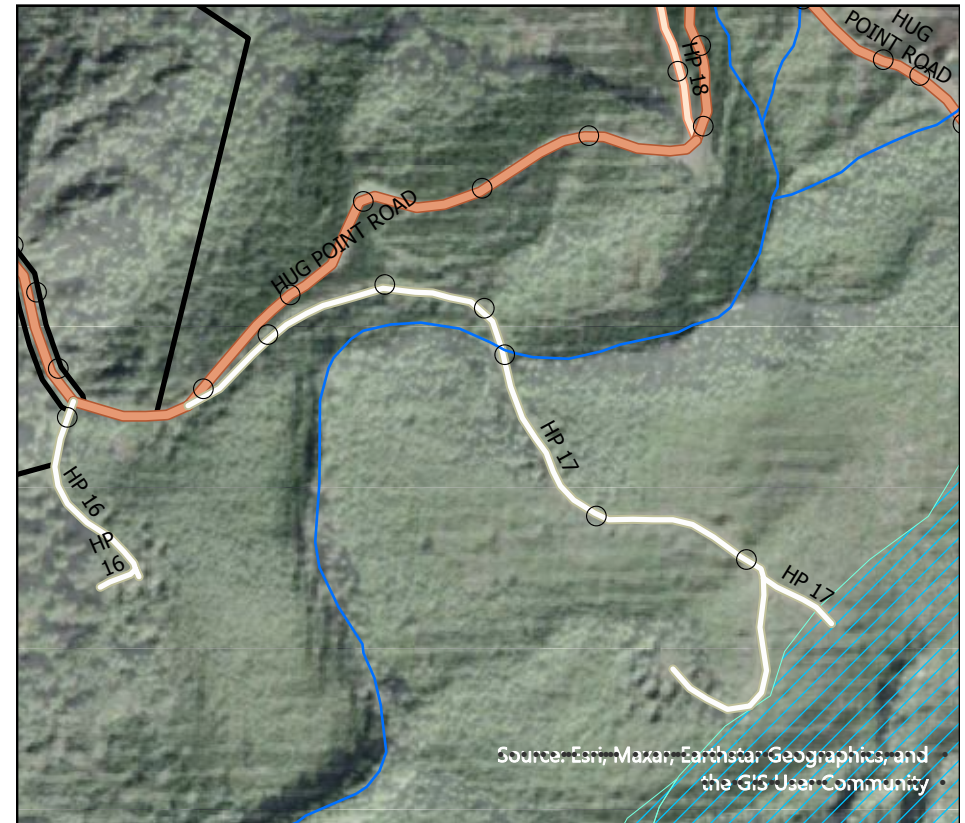
HP17 is the second spur extending S of the Hug Point Mainline. This is a long spur that accesses multiple young stands outside of the drinking water source area. There are recent culvert improvements on this spur. The spur is rock surfaced with significant overgrowth.

Management Recommendations: The road is overgrown and requires brushing. The crown is intact and sod has grown over the road surface. The recommendation is to maintain the sod surface until the road is needed for active management. At that point the sod could be removed and the road re-surfaced with crushed rock. The road should be brushed to keep Alder from growing in the road surface and damaging culverts.

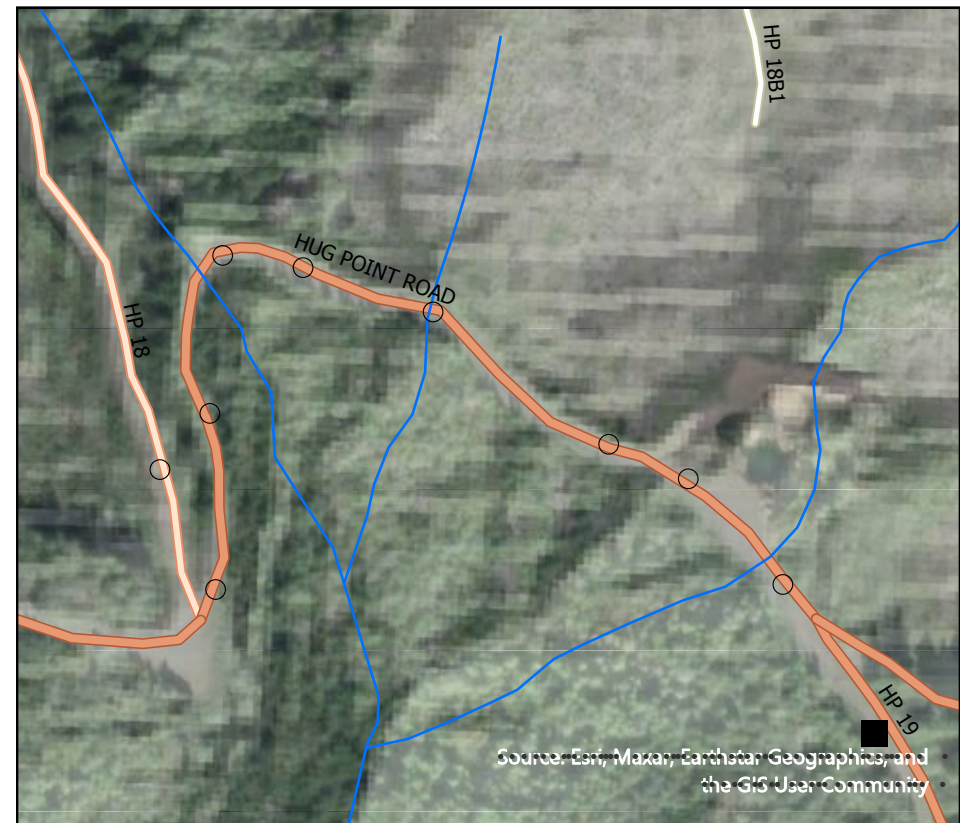
The Hug Point Mainline continues as the primary access, passing a large closed rock pit. The road is well surfaced with some brush growth. The ditch is vegetated and has heavy siltation. In some areas the ditch has completely filled due to collapsing upslope banks. There is also a pronounced hump on the downslope side due to grading. As with other segment, grading may expose road base material.

Management Recommendations: The road requires grading and ditch re-establishment. It may require a traction coat of 1.5" minus crushed rock. Ditches should be re-established with a small excavator. Ditch re-establishment should either leave a vegetated area above cross drains and creeks as a sediment filter, or install small settling ponds (3'x3'x3') uphill of culverts (not at the culvert intake).

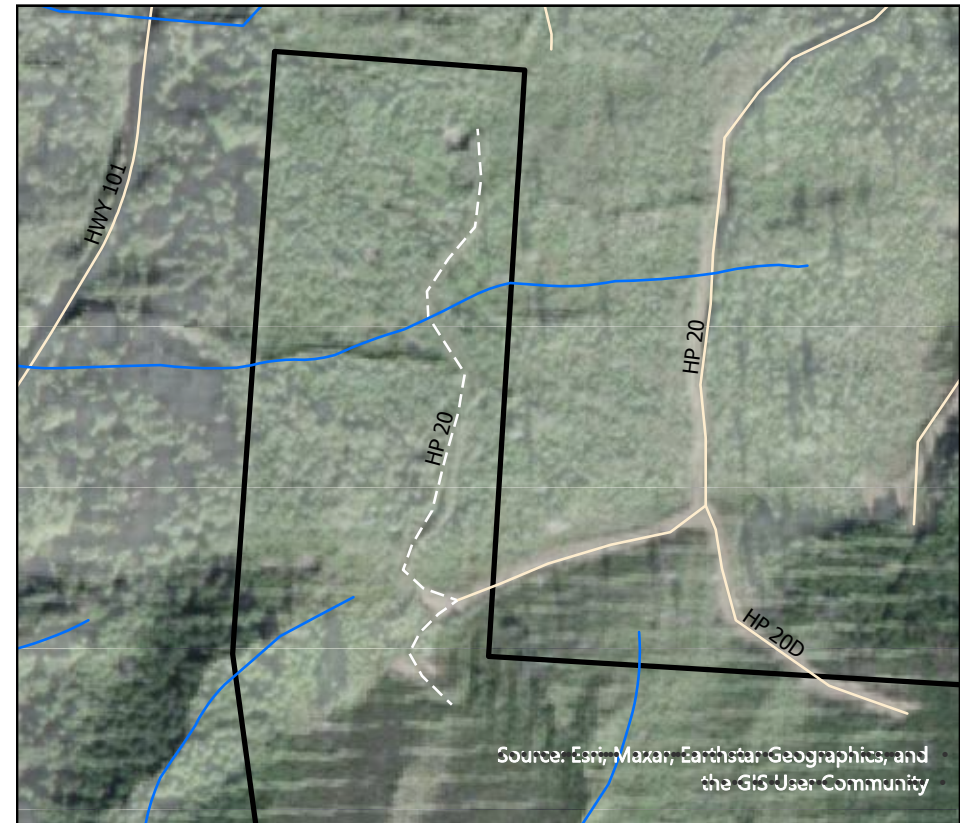
HP20 extends N from the Hug Point Road onto Lewis and Clark Timberland. It then forks with HP20C re-entering the ACF and HP20 eventually going through Oregon Department of Forestry lands and back onto the ACF. These are short spurs with no culverts that have become overgrown. They were last used for PCT access on the N end of the property (the one area that received PCT treatment under Stimson ownership).

Management Recommendations: These roads are only short spurs - they are rock surfaced but overgrown. It is recommended to include these roads in preliminary brushing summer 2023. This will expose any potential road failure points or issues. Assuming no issues, these roads could be abandoned without decommissioning.

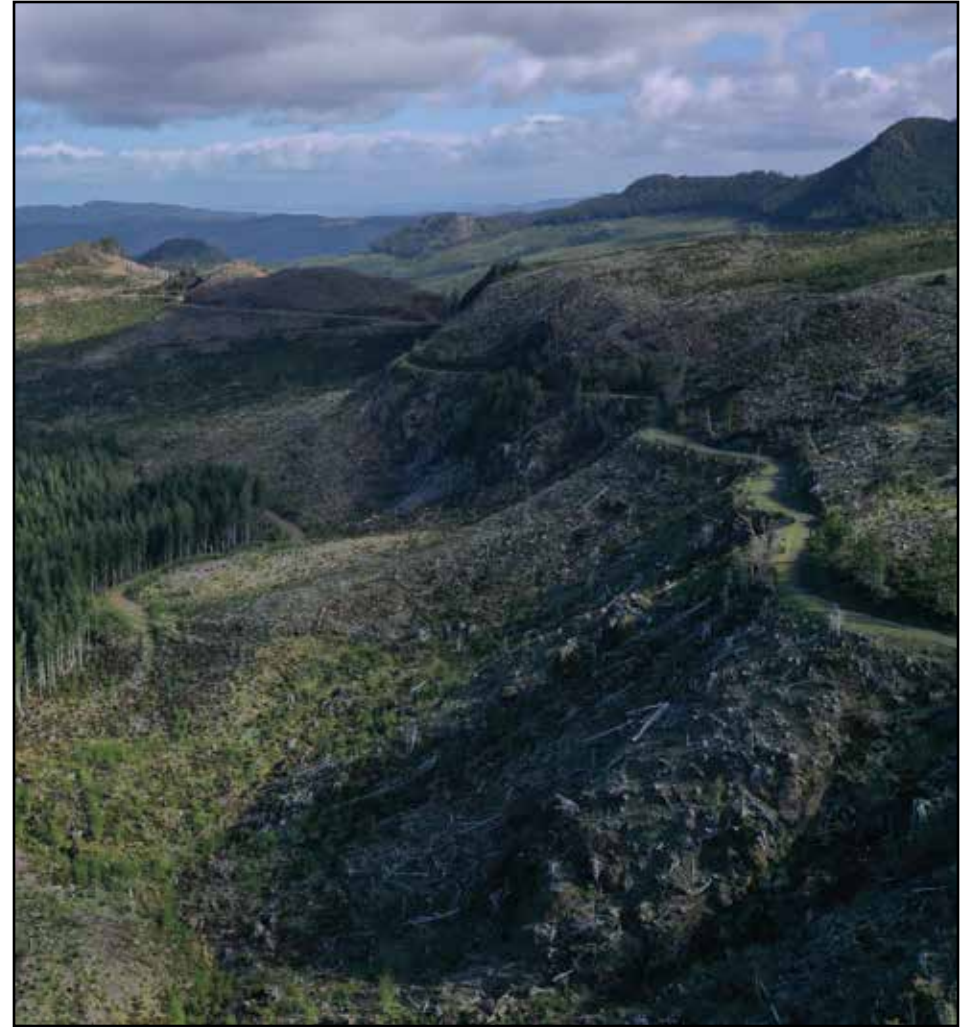
The Hug Point Mainline cuts mid-slope from Lewis and Clark Timber to the 4-way junction at Onion Peak Road. This road is currently closed, and has officially been closed for a number of years. Two landslides onto the road surface have temporarily closed it to all vehicle traffic. The road is built into an extremely steep slope with large areas of exposed basalt bedrock and large buried boulders. The rock is heavily fractured, leading to continued rock fall and erosion issues. In addition, this road cuts across the headwaters of Shark Creek. The entire area surrounding the road has been recently logged. Both the HP23 (below) and Onion Peak Rd (above) cut through this same stand and would allow access for fire, emergency, or forest stewardship activities. Based on the current ACF Multi-Resource Management Plan we do not anticipate active timber harvest occurring from Hug Point Road in this section, even if it were maintained. In addition to areas of rock fall onto

the road, two large slumps exist where the downhill road shoulder is actively eroding, there is at least one failed culvert, and additional culverts that are either partially obstructed or causing active down-slope erosion.

The Hug Point Road cuts across the steepest part of this convex slope, with numerous cliffs directly above the road. A more feasible primary property access would be across the road shown at left side, the HP23, which could be connected to the HP 19 TIE 1.

Management Recommendations: It is recommended to decommission and abandon the Hug Point Road from the property line with Lewis and Clark Timber to the intersection with the Onion Peak Rd. This decommission would include removal of all culverts, filling of the upslope ditch, excavation of the small areas of fill that do exist, and large water bars at 10' increments in all areas where the road bed allows for installation. In areas where the road is built on solid rock or large boulders, ditch filling and log placement in the road surface should force any ditch or road surface water downslope. Finally, the road surface should be covered with at least one "chunk" (a log at least 8' long and 12" diameter) every 50' and planted to native species. Areas with pooling water in the up-slope ditch that could provide invertebrate habitat should be marked and maintained. Large undriveable water bars should be installed at the junction with the Onion Peak Rd and either at the property line, or in agreement with Lewis and Clark, at the last turnaround on Lewis and Clark Timberlands (which are within the DWSA).

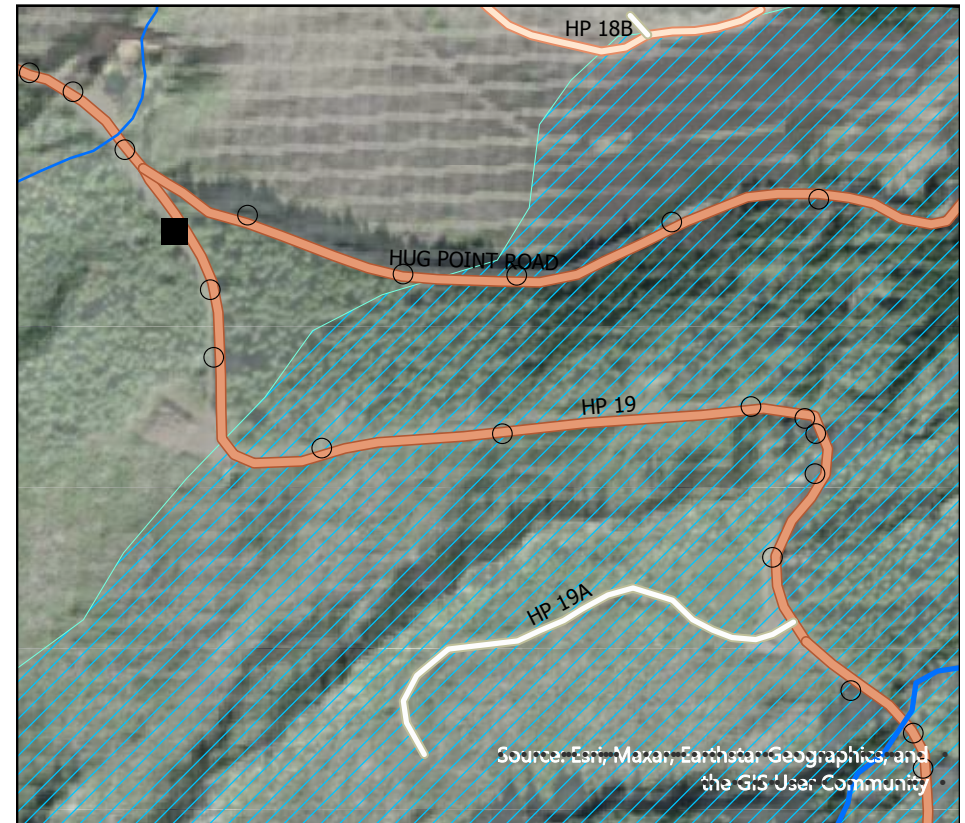
Segment 13

The HP19 is the primary mainline access for the ACF and for the RR. This is a well-built mainline road with minimal issues. It is gated at the junction with the Hug Point Road. The road is surfaced with crushed rock and includes numerous ditch relief culverts and one small stream crossing.

Management Recommendations: This road should be brushed, graded, and have crushed rock added as needed. It does not have the W road shape that many other roads on the property have developed. The ditch is established and heavily vegetated.

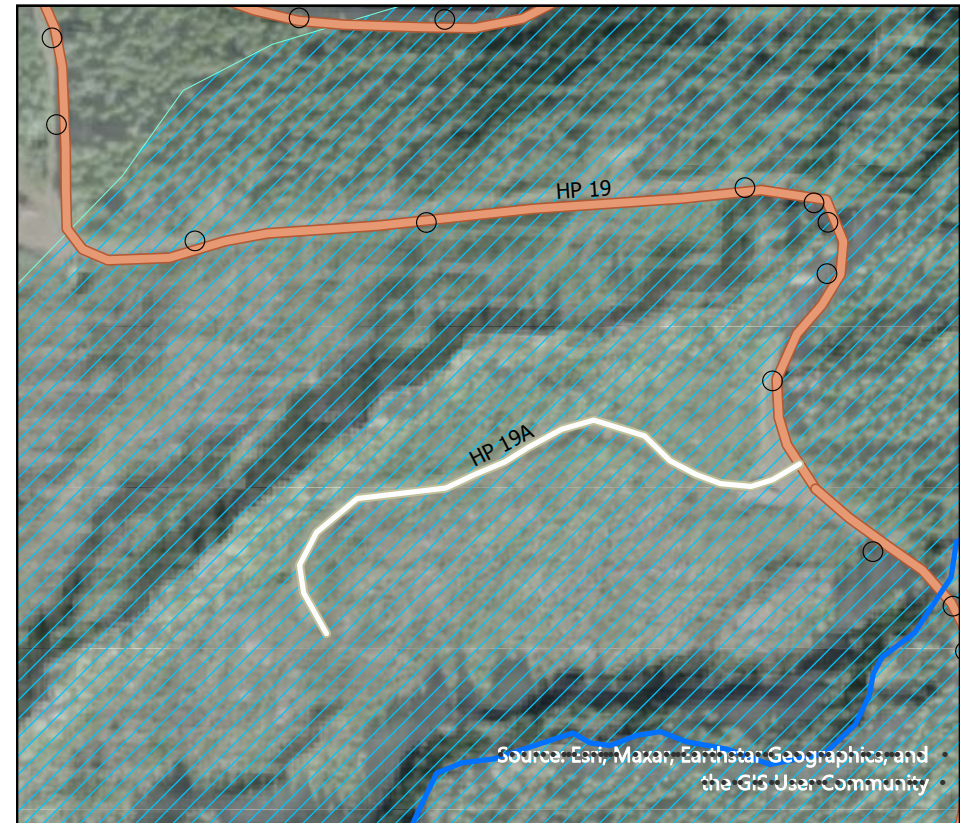
Segment 14

The HP19AS is an abandoned spur that leaves from behind a large spoils pile directly before the Shark Creek road re-alignment. This re-alignment unfortunately blocked two spurs- the HP19A was clearly abandoned well before this though.

Management Recommendations: Continue to abandon.

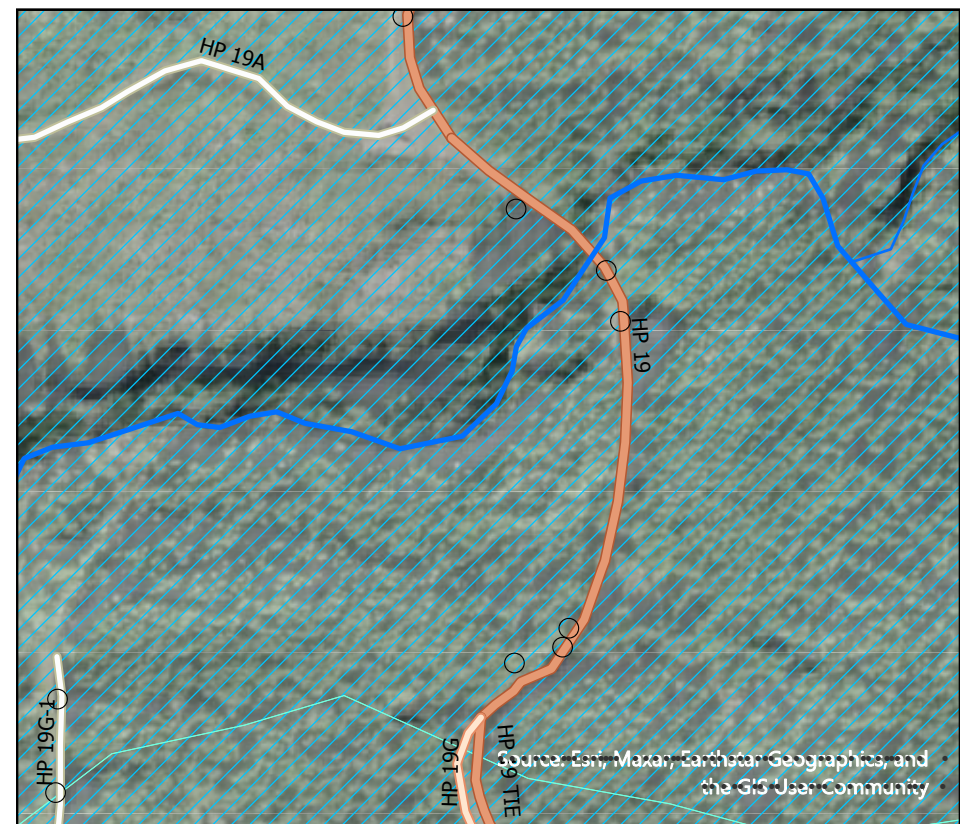
Segment 15

the Shark Creek crossing requires significant curve widening. This could be achieved with cutting and filling at both ends to allow for a straighter segment over the culvert. The culvert is too short and the bank angle steeper than is typically used. Without fully replacing the structure, curve widening with strategic rip-rap placement is the best and most affordable course of action. It is likely that, even without some rebuilding, the structure could fail from normal use and erosion.

Management Recommendations: Other than at the crossing, the road should be brushed, graded, and have crushed rock added as needed. At a minimum,

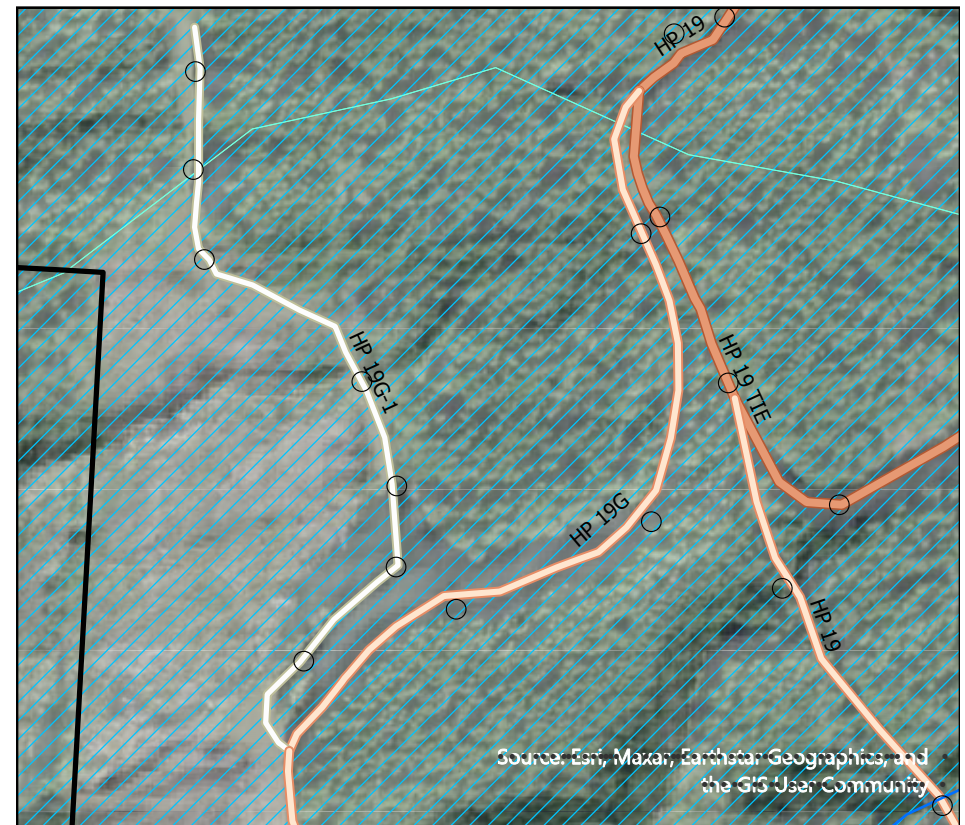
Segment 16

The HP19G was historically a primary access route, but is now a secondary road due to the road closure at Asbury Creek. This road runs through an older forest with significant ditch sedimentation and needle litter on the road surface.

Management Recommendations: The road appears in good condition, but would benefit from ditch re-establishment, grading, and road brushing.

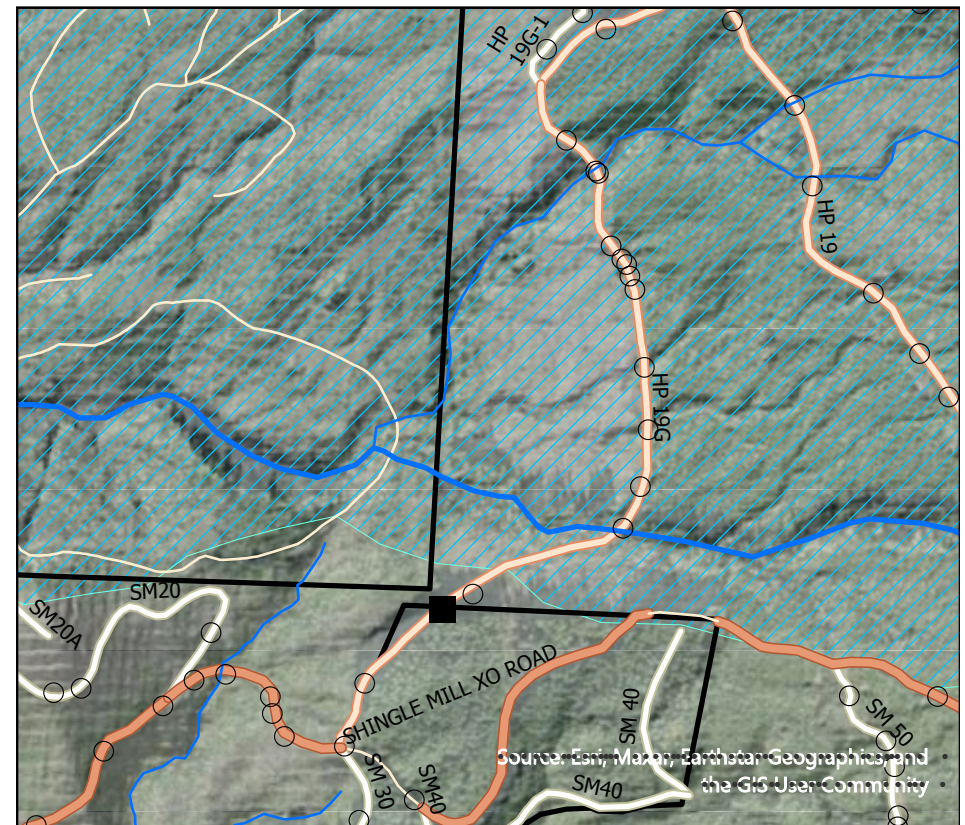
Segment 18

HP19G historically connected the Hug Point Road system to the Shingle Mill road system. This road was a mainline road, however a large segment of road just N of Asbury Creek slumped. This slump is approx. 500' in length and continues to move down slope. An attempt was made to remove culverts and provide new stream channels below two springs, however the intermediate road surface has continued to move down slope. This is a mid-slope road that appears to be built on the toe of a large historic landslide with multiple springs just up-slope of the road. This segment also is in the core of the DWSA.

Management Recommendations: It is recommended to fully decommission this road from the last turn-around on the N side to gate on the S side. This would

include providing proper drainage around the Asbury slump, removing the culvert from Asbury Creek, and removing at least 8 culverts. At the Asbury slump, it is recommended to provide an appropriate low-angle approach on the N and S side of the small tributary to Asbury Creek with graded UTV - passable full bench trails down to the creek. This small seasonal stream would benefit from a short pedestrian bridge since this is a popular hiking route. The area S of this stream requires additional cross drainage and ditch filling - forcing the water into the water bars. The S side of the slump requires excavation of a new stream channel from the road-side seep and excavation of the fault that has create a 4' break in the road surface. To the S, the road crosses Asbury Creek through a 72" metal culvert that was installed in 1995. This is an F stream, however leaving the culvert does not provide any access and will require future removal if not removed currently. It is recommended to fully remove the fill and decommission the road back to the gate on the S end.

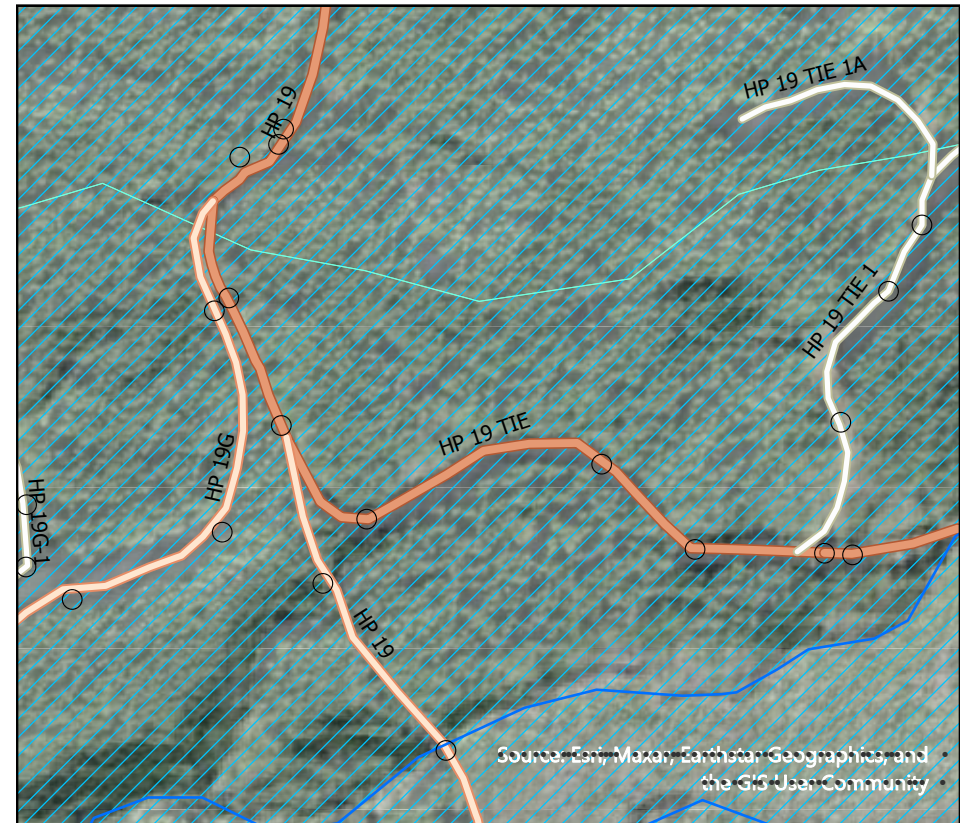
Segment 19

HP19 Tie continues as the primary access to the RR and upper portions of the ACF. At this segment the road begins to climb. The road appears to be built on a thick rock base. The ditch is vegetated with moderate siltation and appropriate cross drainage.

Management Recommendations: HP19 should be brushed, graded, and have culverts cleared. Some areas of ditch should be re-established.

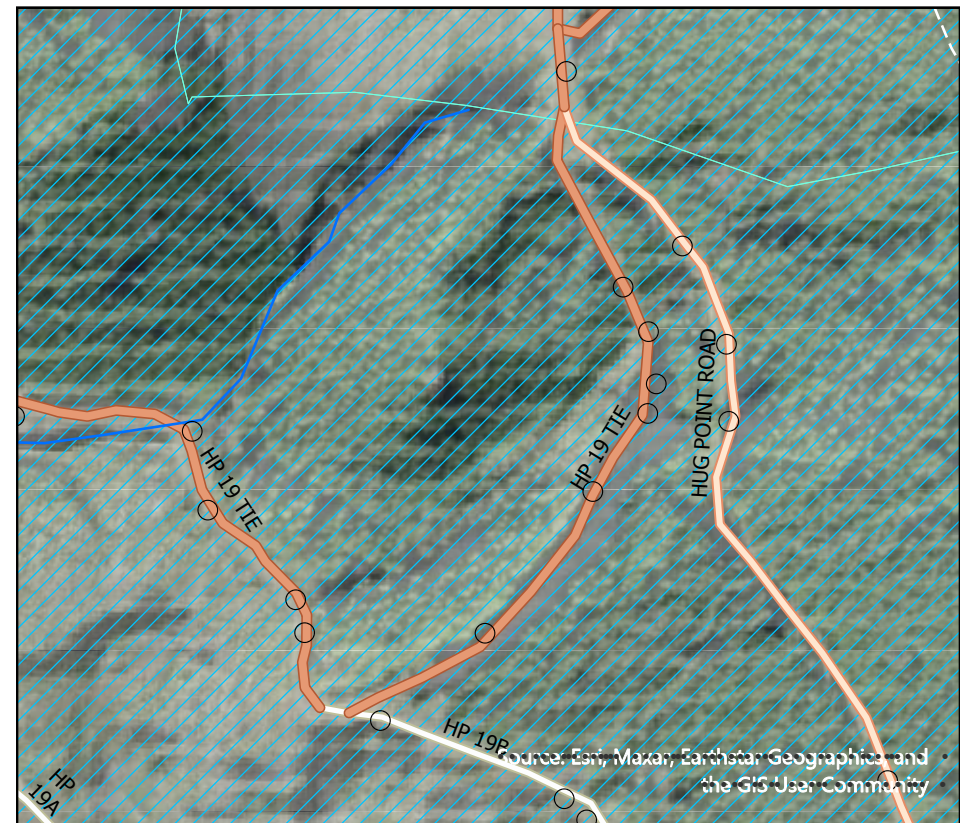
Segment 24

This section of the HP19 TIE is a steep mid-slope road cutting through a wet and boulder choked slope. The road is built almost entirely on rock base with a crushed rock surface and narrow ditch. The downslope side has a steep rocky bank and many ditch relief culverts and stream crossings. While in better condition than the next segment downhill, this segment also has a slight W profile and sediment filled ditch.

Management Recommendations: This segment requires re-shaping with an excavator followed by an application of surface rock. Due to the height of the fill, caution must be exercised with a vibrating roller and water / rock trucks. Adding too much rock could result in a loose surface - two spreads - 1.5" minus followed by .5" minus could improve the packing of the rock into the road surface. Wherever possible, the road should

be out-sloped and culverts cleaned / ditches re-established.

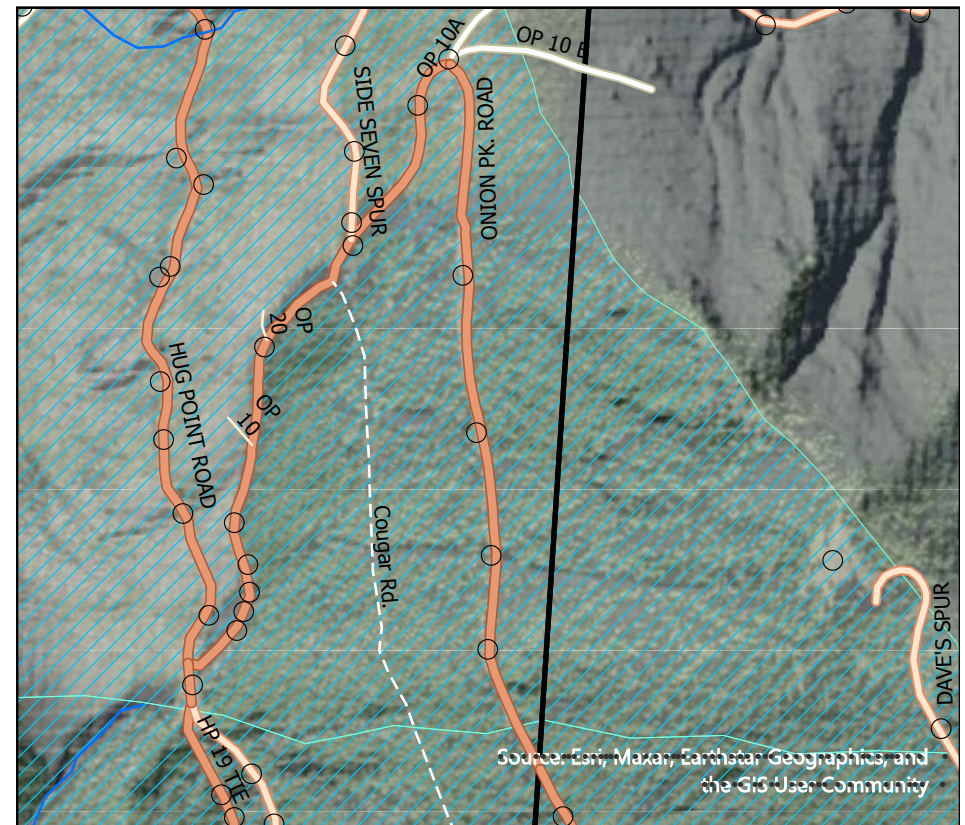
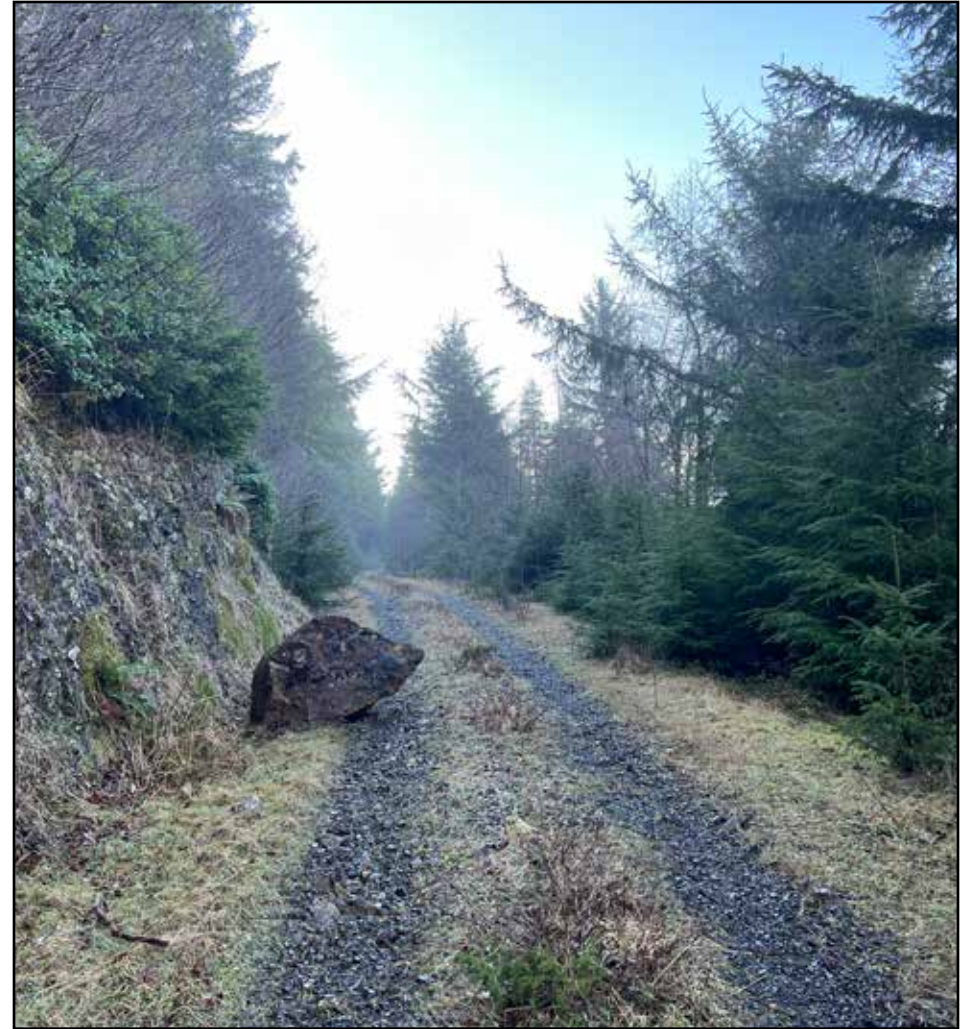
Onion Peak Rd changes significant at the junction with OP10B. Below that point the road has received regular maintenance and upkeep due to frequent logging by past owners. Above that point there has been very little active management in the recent past, resulting in a lower level of road maintenance. The road is still built on a rock base, with large boulders frequently poking through the road surface material. The ditch is filled with sediment and the road has a distinct W profile. The geology also shifts as the slope becomes steeper and the road winds around large basalt outcrops. Only a small portion of this road is owned by the ACF, however it provides the primary access to the Onion Peak portion of the RR. Other shifts include the existence of older forests, vernal pools along the up-slope road ditch.

Management Recommendations: For the short segment of the "old" Onion Peak Rd on the ACF, minimal maintenance is needed. In addition, there is a large boulder in the road that forces vehicles to drive on the outside shoulder. This boulder should be removed as soon as possible. The road has exposed road base material poking through the road surface. Following brushing, an excavator may be able to re-shape the road and pull down the outside shoulder. This road should have an out-sloped profile. This will require the addition of surfacing rock and re-grading. Rock is estimated at 23 loads, 322 cubic yards , 1.5" minus 4" lift. In addition, a grader and roller will be required for 4-6 hrs each.

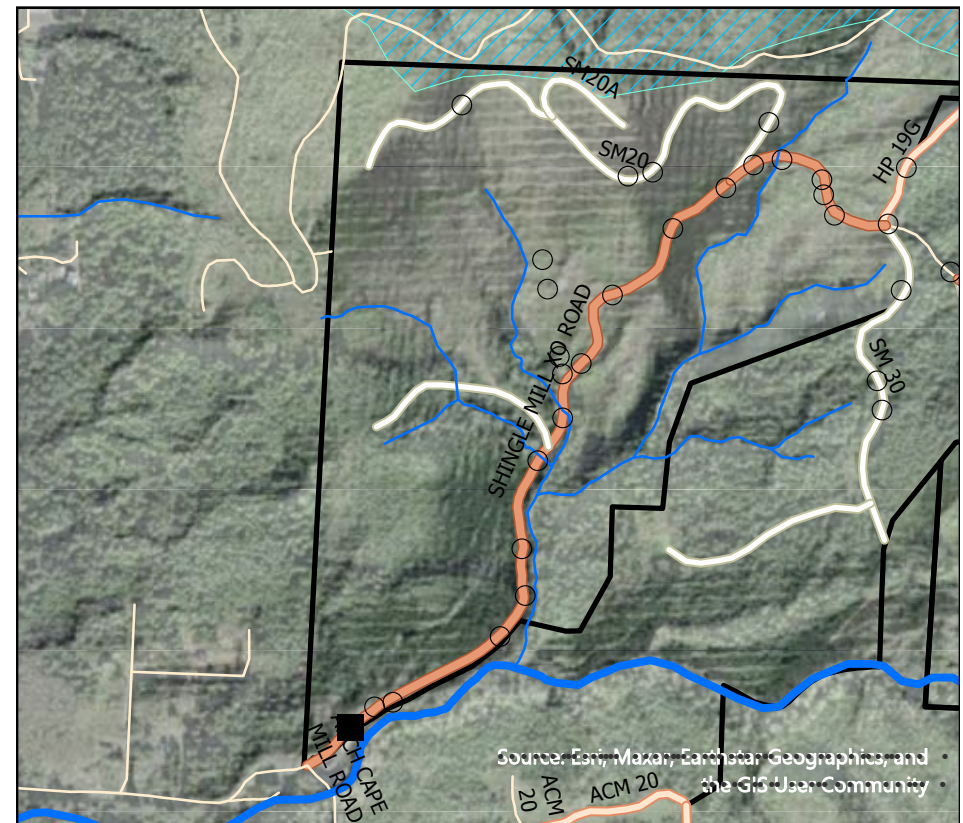
Segment 34

The Shingle Mill XO is the second primary access to the ACF as well as to small portions of the RR along Shingle Mill Creek. This is a road that was clearly not built to serve as a mainline road, but was tied into the primary road system either following the removal of the bridge over Shingle Mill Creek or for other operability reasons. The road is built on a thin road base without the surface rock seen elsewhere on the property. The road is wet in the first 1000' before climbing steeply for another 1000' and then leveling out. The climbing section has loose surface rock and exposed road base rock.

Management Recommendations: This road needs significant work first with an excavator to remove sod and organic material from the road surface. Once a clean road base is exposed it will require a 8" lift for the first 1000' followed by a 4" lift with a high fines compo-

nent for the next 1000'. The final approximately 1000', which is relatively level, only requires minor re-grading and a skim coat. These distances are approximate and should be marked before rock is spread (estimated 40 loads of 1.5"-)

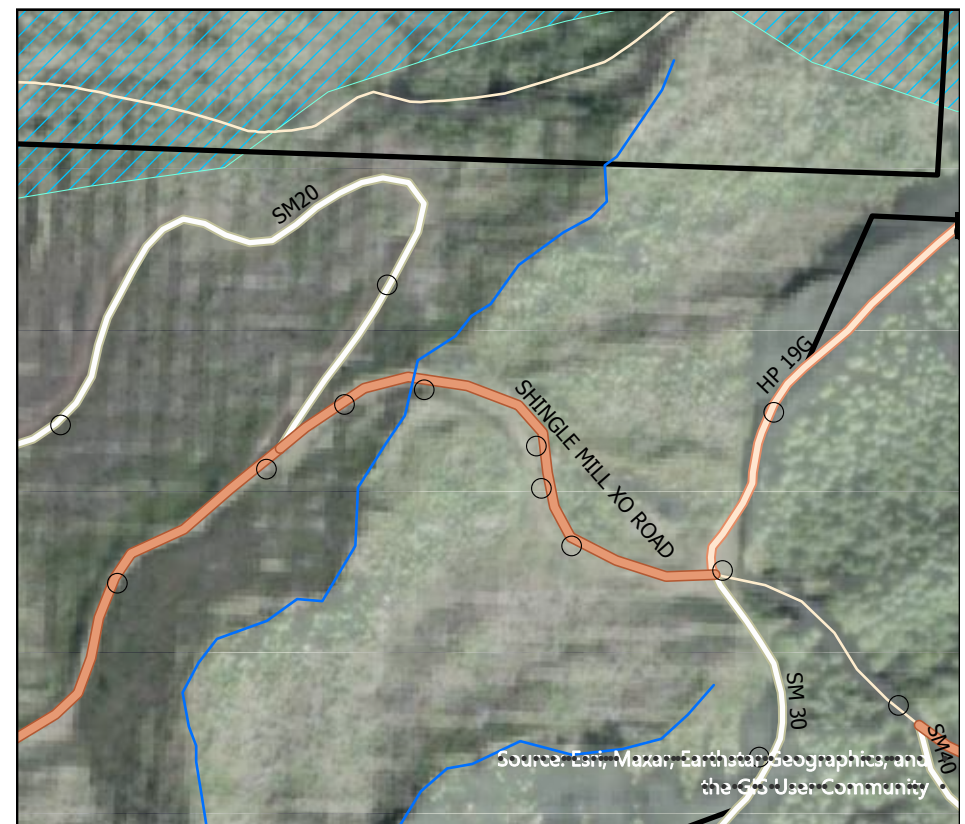
Segment 36

The Shingle Mill XO crosses over a small tributary stream before climbing very steeply through a young stand to the 4-way junction with the HP19G and SM30. This road is incised with loose surface rock, heavy vegetation growth, and non-functional ditches. It appears that this segment may have been built to tie the Shingle Mill Rd into the rest of the road system.

Management Recommendations: While a re-alignment of this segment could have benefits, no good alternate location exists. Instead, it is recommended to increase the fill height, provide improved ditches, and re-surface / compact the road surface. Initially, the road should be brushed extra wide and ditches established with an excavator. At that point any re-shaping of the road surface should occur. 4-6 loads of 4" road base will be required to solidify the grade over the stream crossing, followed by road surfacing with a 4" lift of 1.5" minus. The road should be either track compacted or

8.5 stations 4" lift = 8.5 loads or 119 cubic yards 1.5" minus

4 stations 2" lift .75" minus - 2 loads or 28 cubic yards

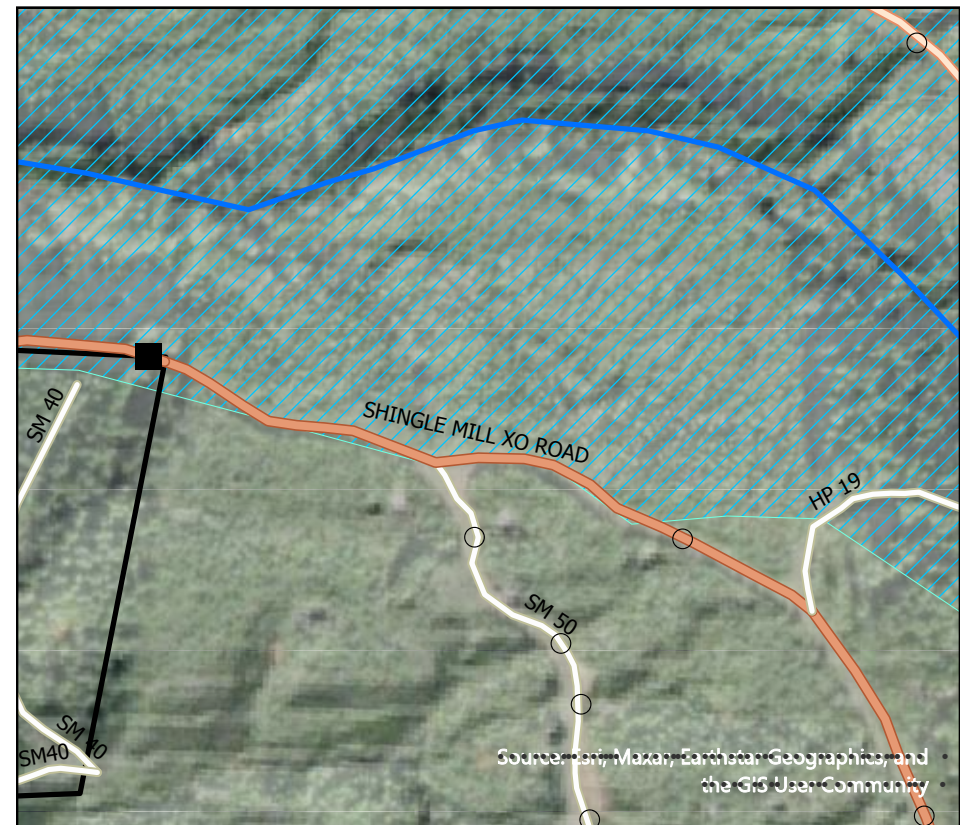
Segment 38

The Shingle Mill XO continues to climb to a saddle where it meets the other end of what used to be the HP19, but is now a stranded spur. This segment is almost identical to the preceding section, with a slight W shape but overall good condition.

Management Recommendations: This segment requires brushing followed by re-shaping of the road surface and removal of sod using an excavator. A traction coat of 1.5" - rock with a 2" thick "driveway spread" should provide sufficient lift to stabilize the road surface.

Rock required is estimated at 84 cubic yards / 6 loads 1.5" minus driveway spread. Re-shaping and sod removal should take 8-10 hrs.

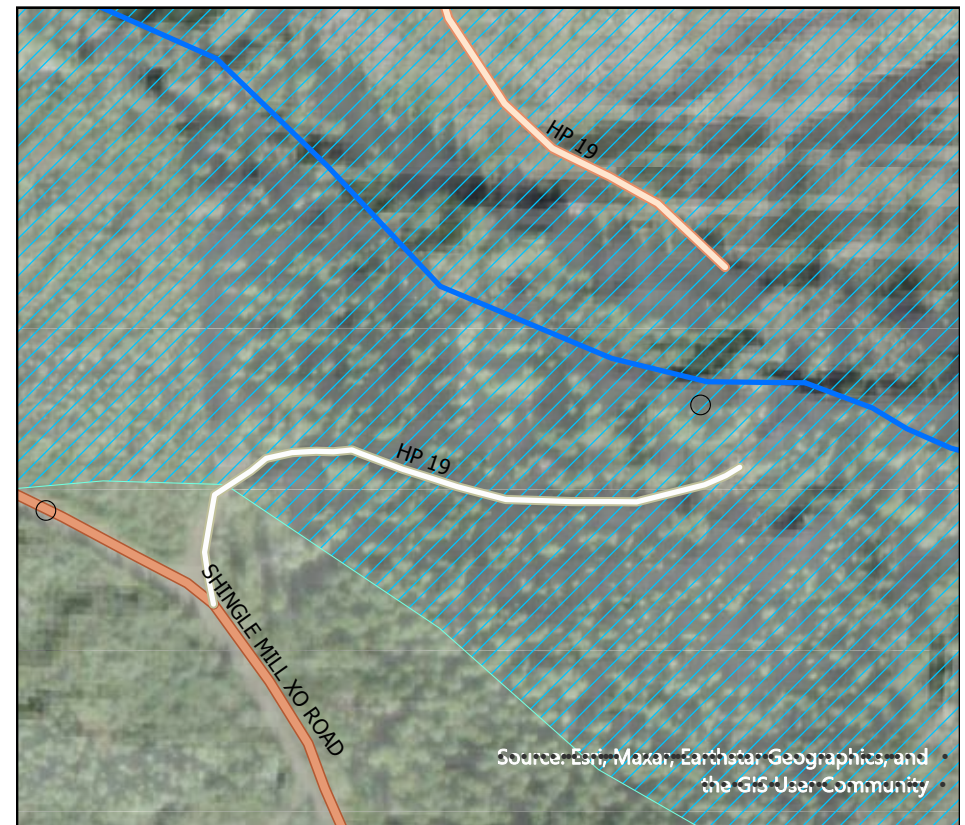
Segment 39

HP19 is a short grass surfaced spur that used to provide primary access across the property. A large stream crossing on Asbury Creek was removed from the HP19 along with a 200-300yd slump in the road N of the stream crossing. In addition, a culvert approximately 100' before the end of the road appears to be failing and pooling water.

Management Recommendations: This segment requires brushing. In addition, a culvert 100' before the end of the road should be removed.

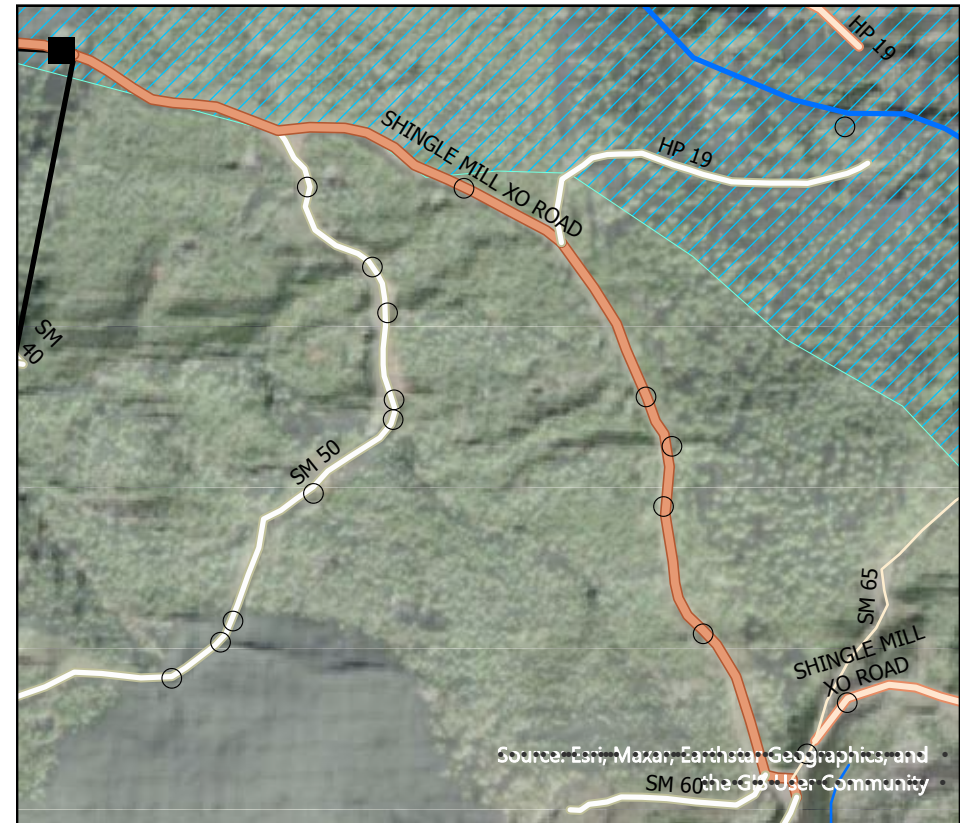
Segment 40

The Shingle Mill XO continues to climb to a 5-way junction with SM60, SM65, and an unnamed 4wd road.. This segment is almost identical to the preceding section, with a slight W shape and overgrowth but overall good condition.

Management Recommendations: This segment requires brushing followed by re-shaping of the road surface and removal of sod using an excavator. A traction coat of 1.5" - rock with a 2" thick "driveway spread" should provide sufficient lift to stabilize the road surface.

Rock required is estimated at 98 cubic yards / 7 loads 1.5" minus driveway spread.
