Rainforest Reserve and Arch Cape Forest
Ecological Road Assessment

Completed by Springboard Forestry LLC
Client: North Coast Land Conservancy
7/7/2023

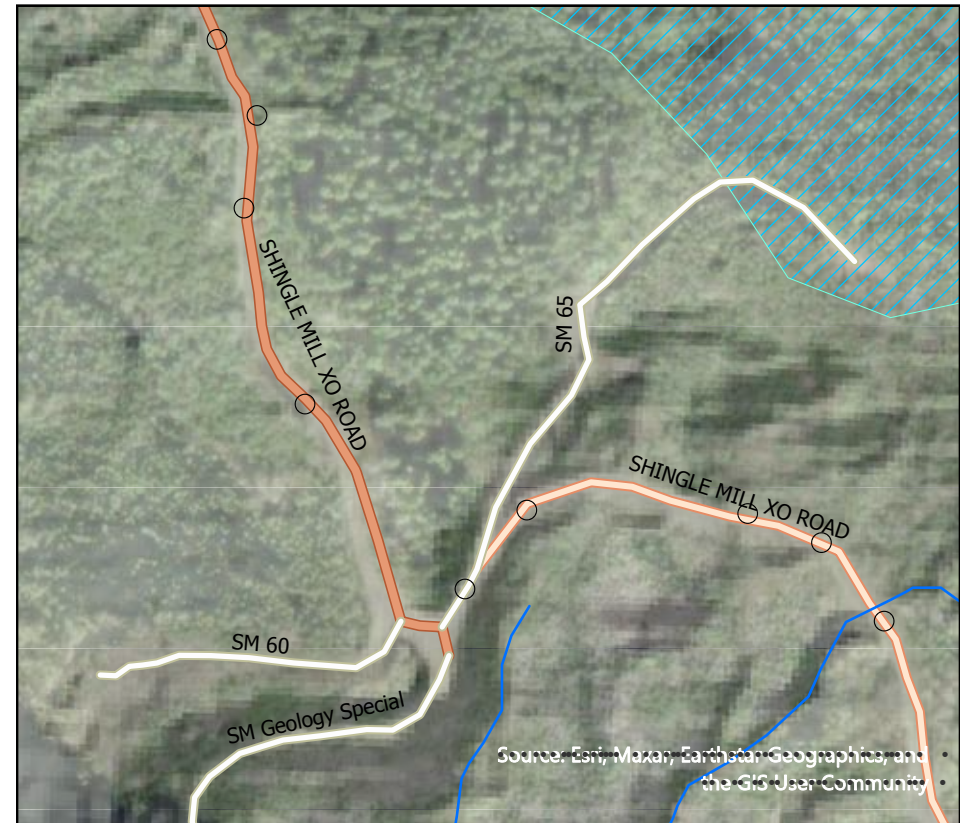
Segment 41

These are two short abandoned spurs that head NE and SW from the 5-way junction with Shingle Mill XO. Both are walkable but no longer driveable - although the appraiser did drive a surprising distance up one road in a Honda Element SUV. This is more a testament to the Honda than to the road condition. SM 65 is badly eroded and incised deeply.

Management Recommendations: Continue to abandon SM 60, SM 65 requires active decommissioning with an excavator to get water off of the road surface.

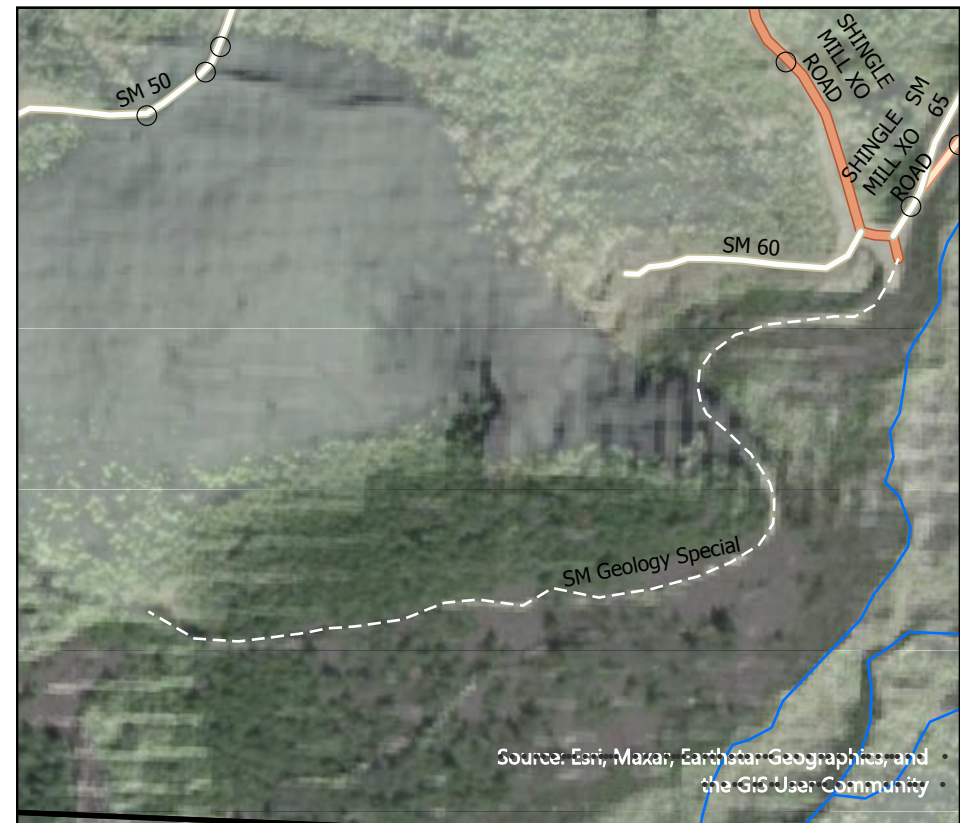
Segment 42

This is a long and impressive abandoned spur! It is not driveable but is a pleasant walk and, after a few hundred feet of thick alder, becomes more easily passable. The final segment of this road is blasted into solid basalt bedrock on the shoulder of what appears to be a historic lava dome. This is one of the more unique logging roads found on the property and poses minimal risk of failure.

Management Recommendations: Continue to abandon and go for a nice hike up the SM geology special.

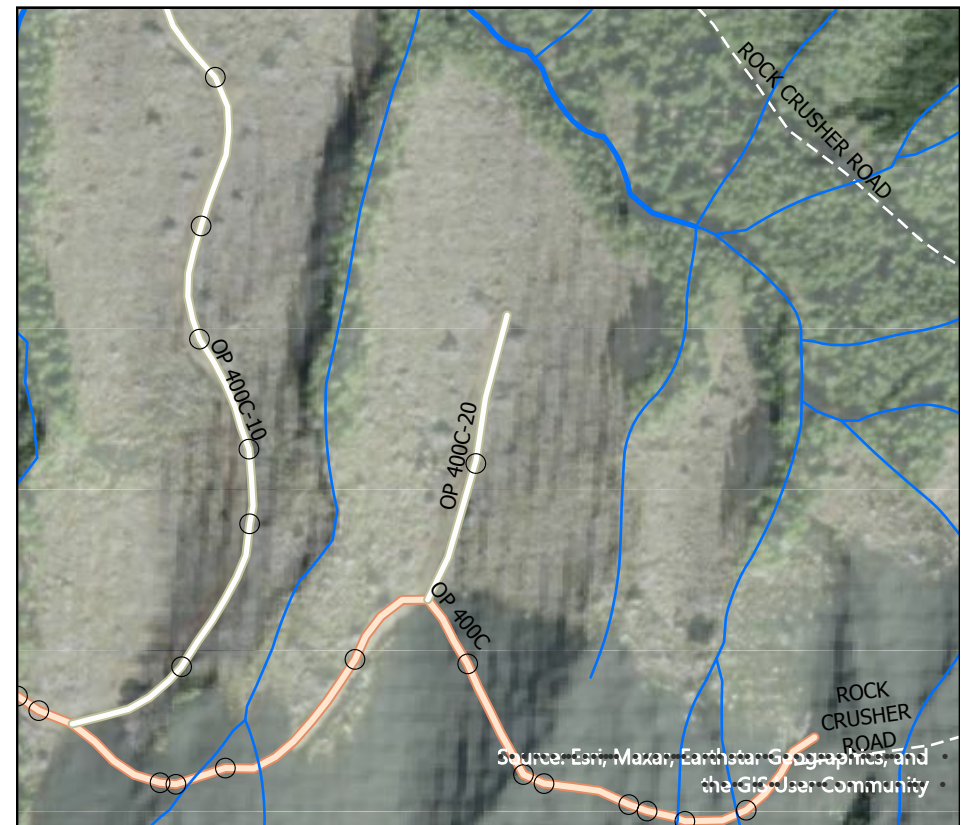
Segment 47

The OP400C-20 is a short spur extending north from the OP400C. This is a steep spur that ends on a landing, with a single, fully sediment filled culvert. The road is recently built and runs down a small ridge into the unit.

Management Recommendations: Due to the high level of sediment transport in the ditches it is recommended to decommission this spur. This would entail removal of 1 culvert, filling the ditches, creation of water bars at 50' increments, sufficient excavation of the road surface to allow for replanting, and the actual replanting activities. It is estimated that an excavator would take approximately 20 hrs to complete this work, and no material would need to be end-hauled.

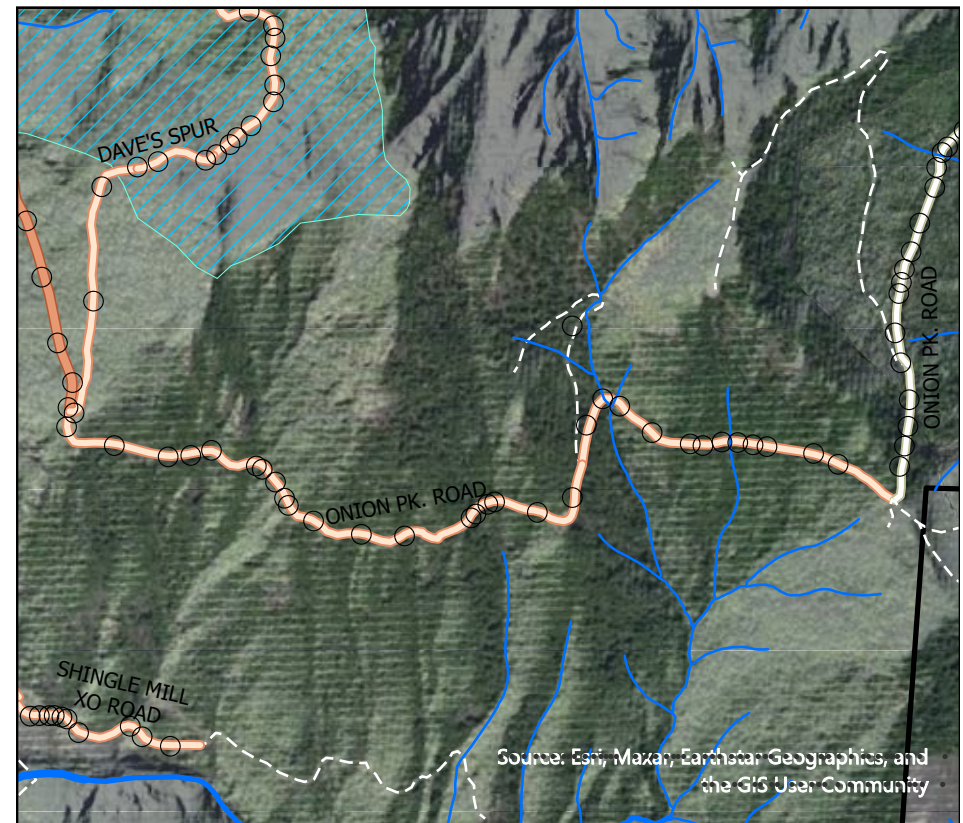
From the junction with Dave's Spur headed East, Onion Peak Rd changes notably. The road past this point is narrower, on a very steep slope, and has had minimal use or maintenance. There are multiple closures due to either slumping on the downhill side or rockfall onto the road surface. There are many generations of culverts, some of which are well placed and function, some of which are slowly failing, and many of which are mid-failure or failed. Failures range from rotten bottoms to shotgunning and erosion. Past this point there are many old log puncheons that are slowly collapsing, in some cases causing downhill erosion and / or holes in the road surface itself. One unique feature is a relatively new culvert built under the road in a location where the water appears to be flowing through boulders another 20' below the culvert.

Management Recommendations: The Onion Peak Rd past Dave's Spur is in poor shape with numerous forms of road failure, including failed culverts, erosion, rockfall, and collapsing road base. The road has significant sod and a frequently plugged uphill ditch. One result is a set of vernal pools in the uphill ditch line that provide unique habitat. At a minimum, this road should have failed culverts replaced or removed and rockfall removed from the road surface. In areas with culvert removal required, the road could be converted to outsloped. Rolling dips could substitute for culverts in some cases. It is safe to assume that this will only ever be a dry-season road from this point forward. The log puncheons will be very difficult to replace- most are built on very steep slopes with significant erosion downhill. It may be necessary to wait for failure and then replace with rip-rap and outsloped rock road base. Some of these failures could cause long, shallow landslides below the road. Alternatives include complete decommissioning or near-term removal of the puncheon logs and replacement with riprap.

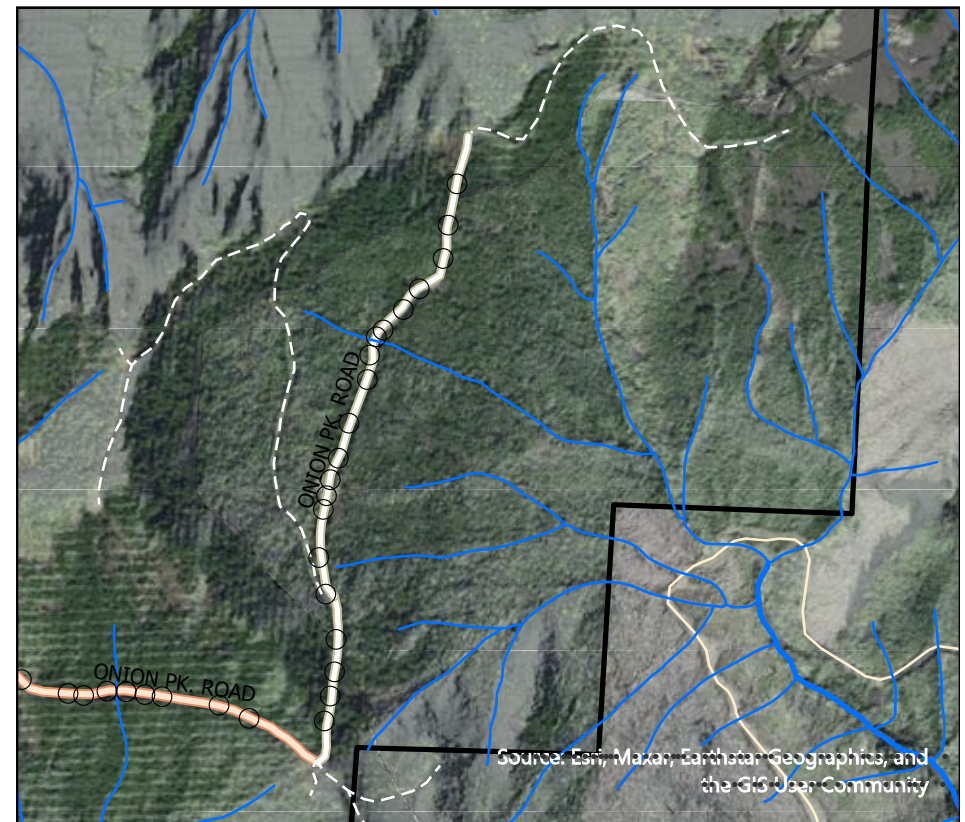
Beyond the 90 degree turn where Onion Peak Rd. turns north and an old spur continues east, the road continues to degrade. While numerous culverts have been replaced or added, old log puncheons are frequent and the ditch is heavily clogged. Again, this has created some unique habitat in roadside vernal pools. These same pools are saturating the road fill and leading to the decomposition of log puncheons.

Management Recommendations: This final segment of the Onion Peak Rd is no longer drivable. At a minimum, removal of rock fall and cleaning ditches would improve road condition. Many segments of the road are sod covered, which has helped to stabilize the road surface. This road serves no functional purpose and would be difficult to impossible to use for commercial purposes. Removal of log puncheons and culverts

along with frequent water bars would be an appropriate form of decommissioning. This segment has lower complete failure risk than the preceding segment and would be lower cost to decommission.

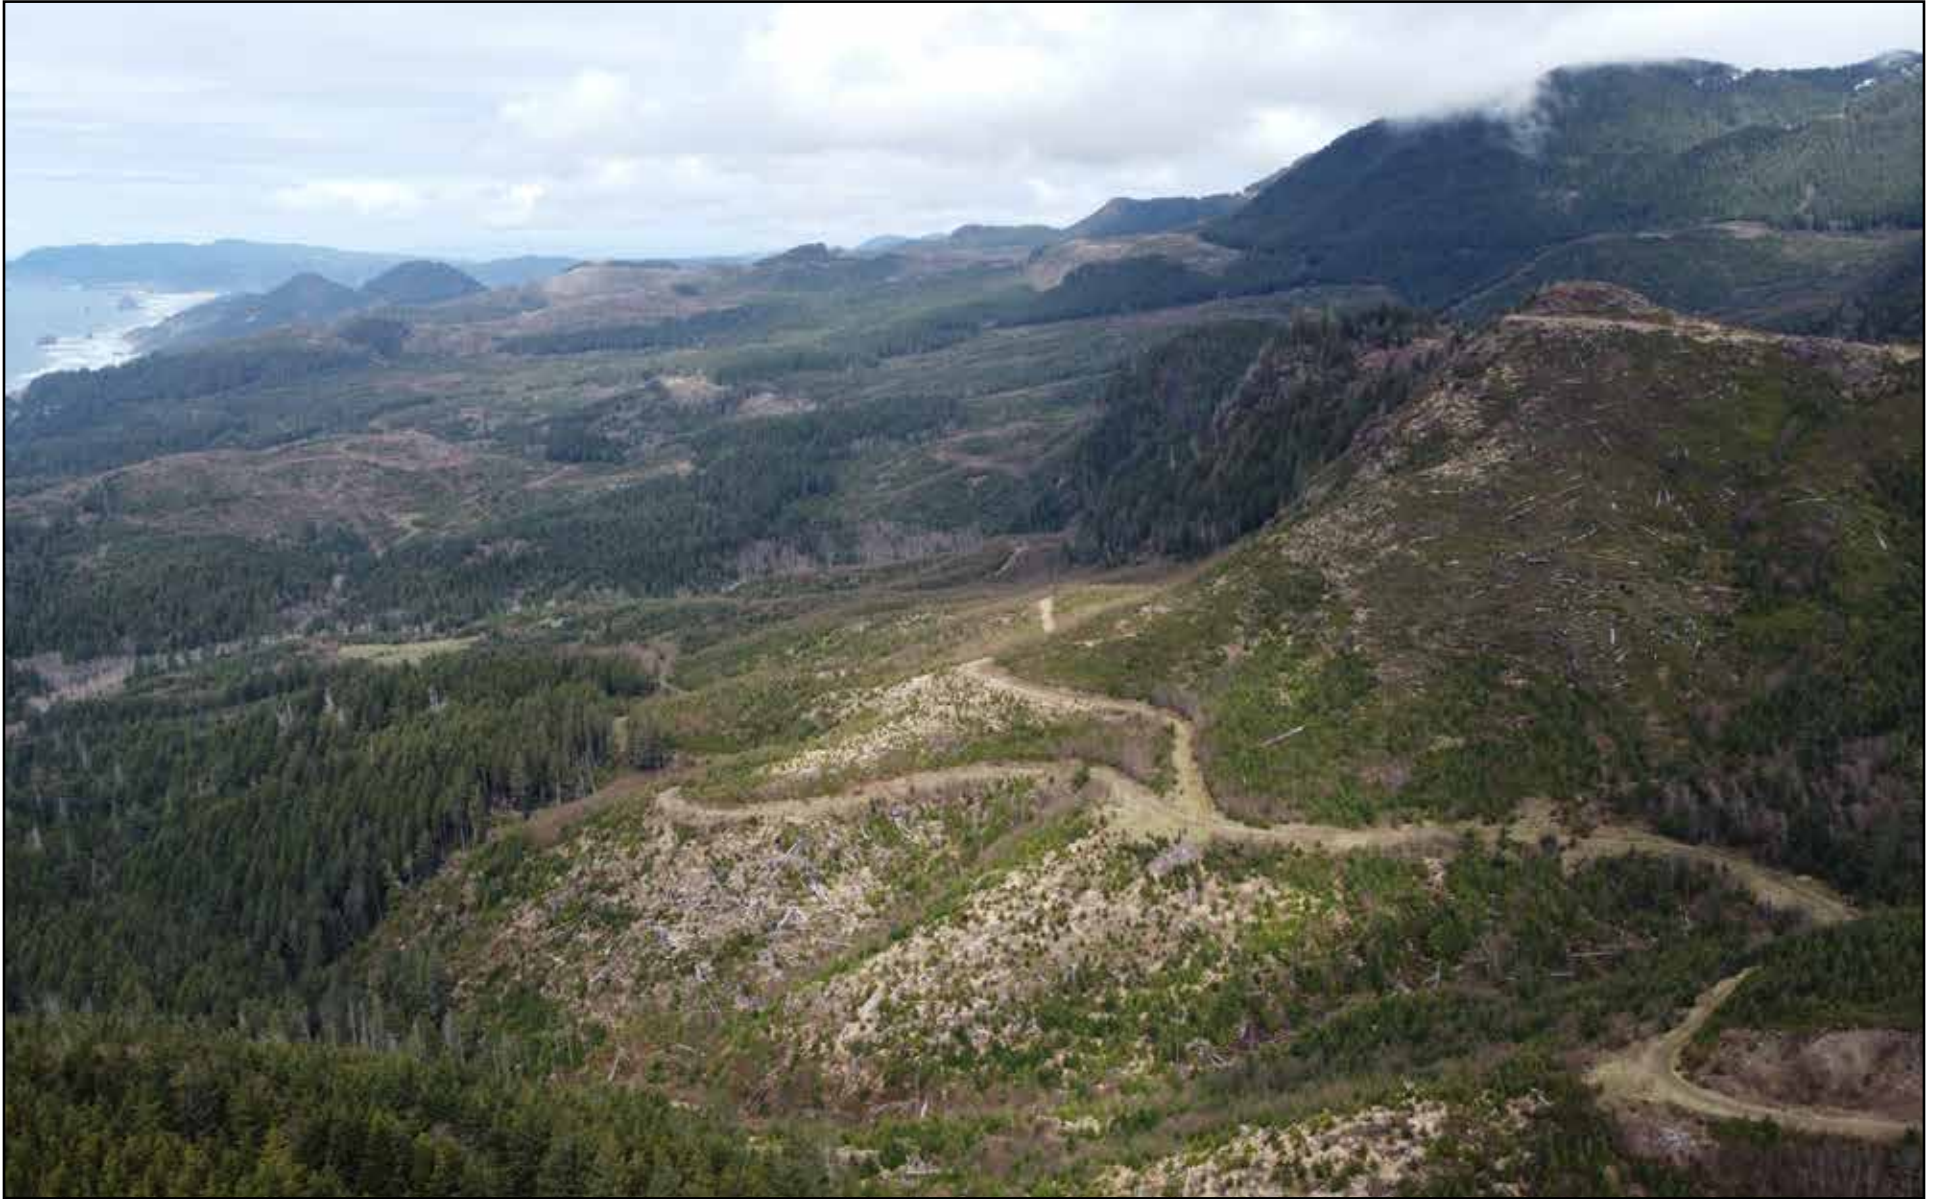
Segment 57

ACM 45 and 50 are short spurs used for recent operations that extends NW from near the junction of Falcon Cover Rd and Arch Cape Mill Rd. They are rock surfaced and serves no present purpose.

Management Recommendations: The ACM 45 has no culverts. It can be abandoned and re-opened as needed. ACM 50 has two culverts that should be removed prior to abandonment

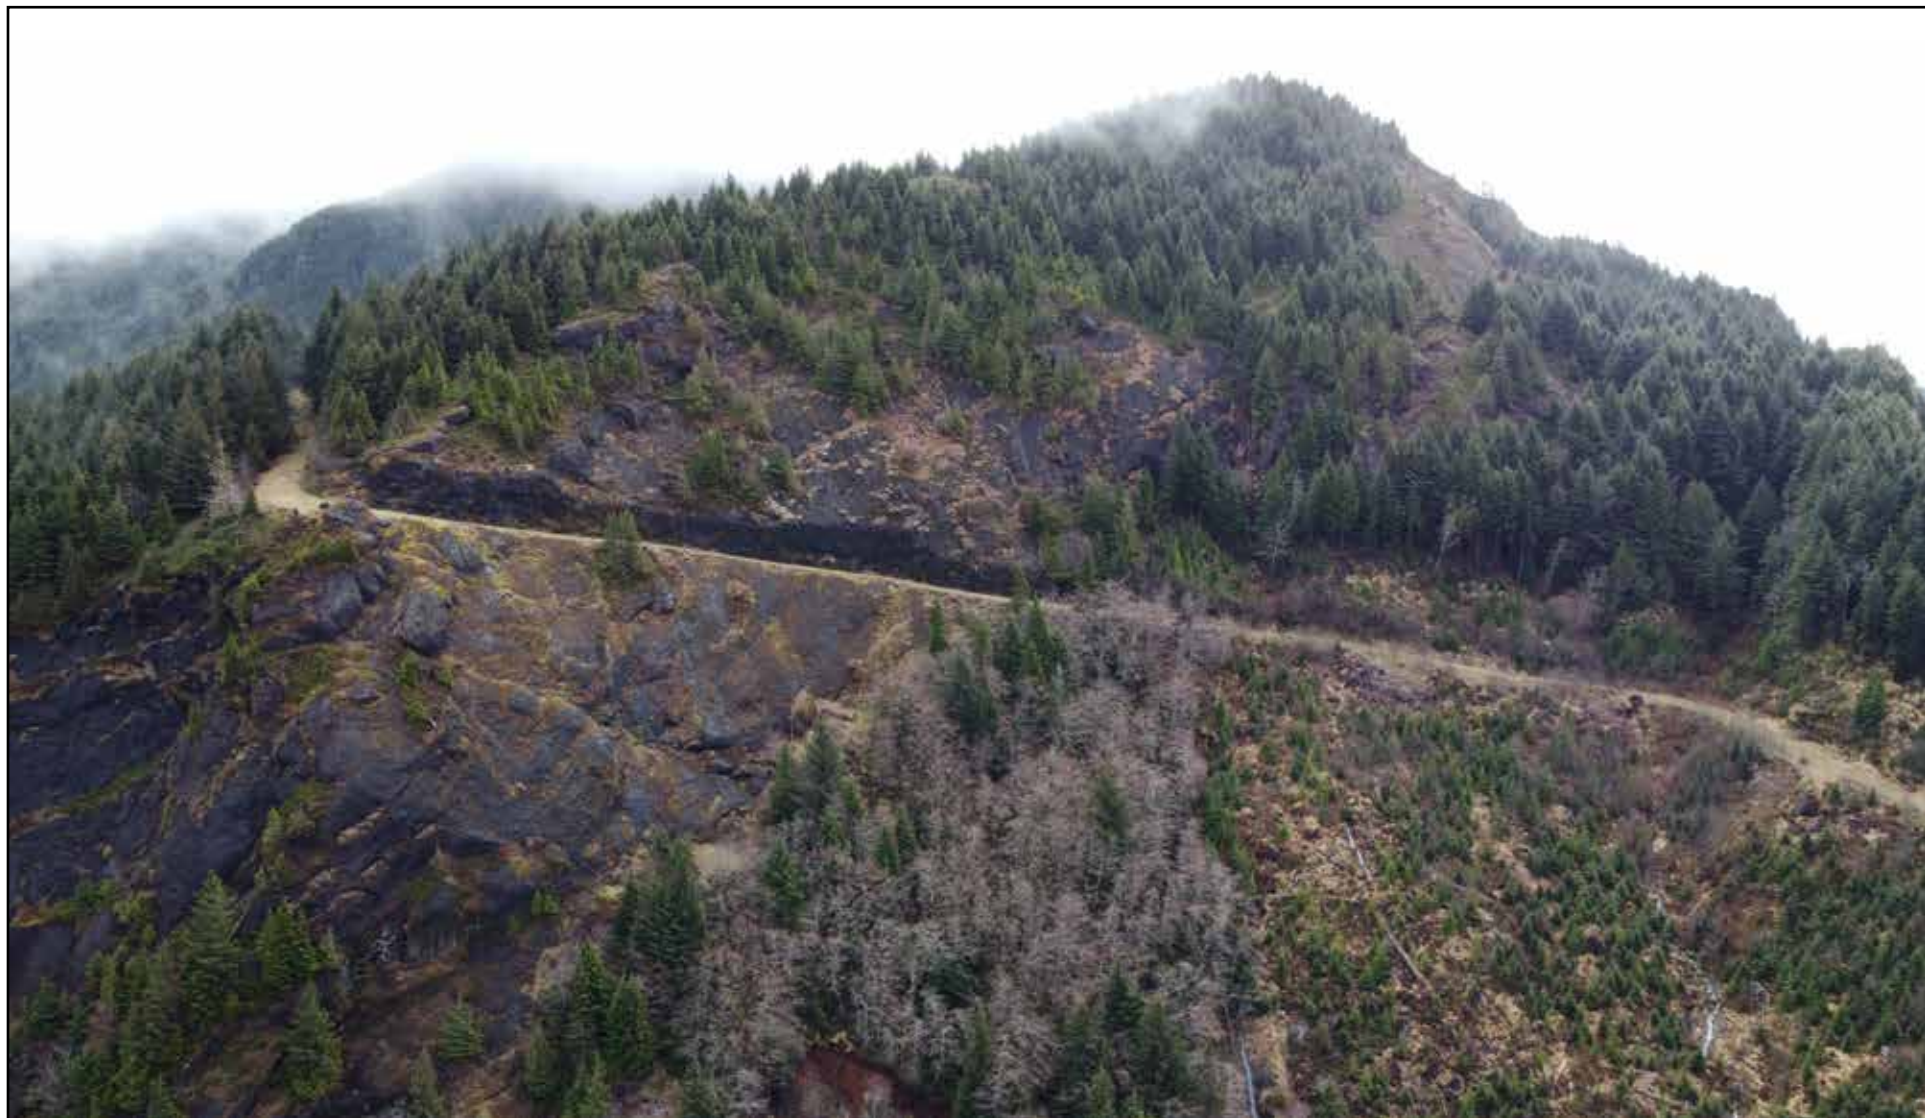
Segment 64

From the property line, the Shingle Mill XO re-enters the Shingle Mill Creek drainage and cuts across a steep slope. There is a large slump directly where this segment re-enters the property, and numerous additional slumps before a large landslide completely closes the road. This is a mid-slope in-sloped road with numerous segments blasted into bedrock.

Management Recommendations: The Shingle Mill XO Road serves no current practical purpose, given especially that any future management would occur from the Hug Point Rd above. A failure at any of the existing slumps would generate a very difficult scenario for further decommissioning. Hence, it would be wise to decommission this entire segment by removing culverts, filling ditches, and establishing water bars wherever the road in-slopes.

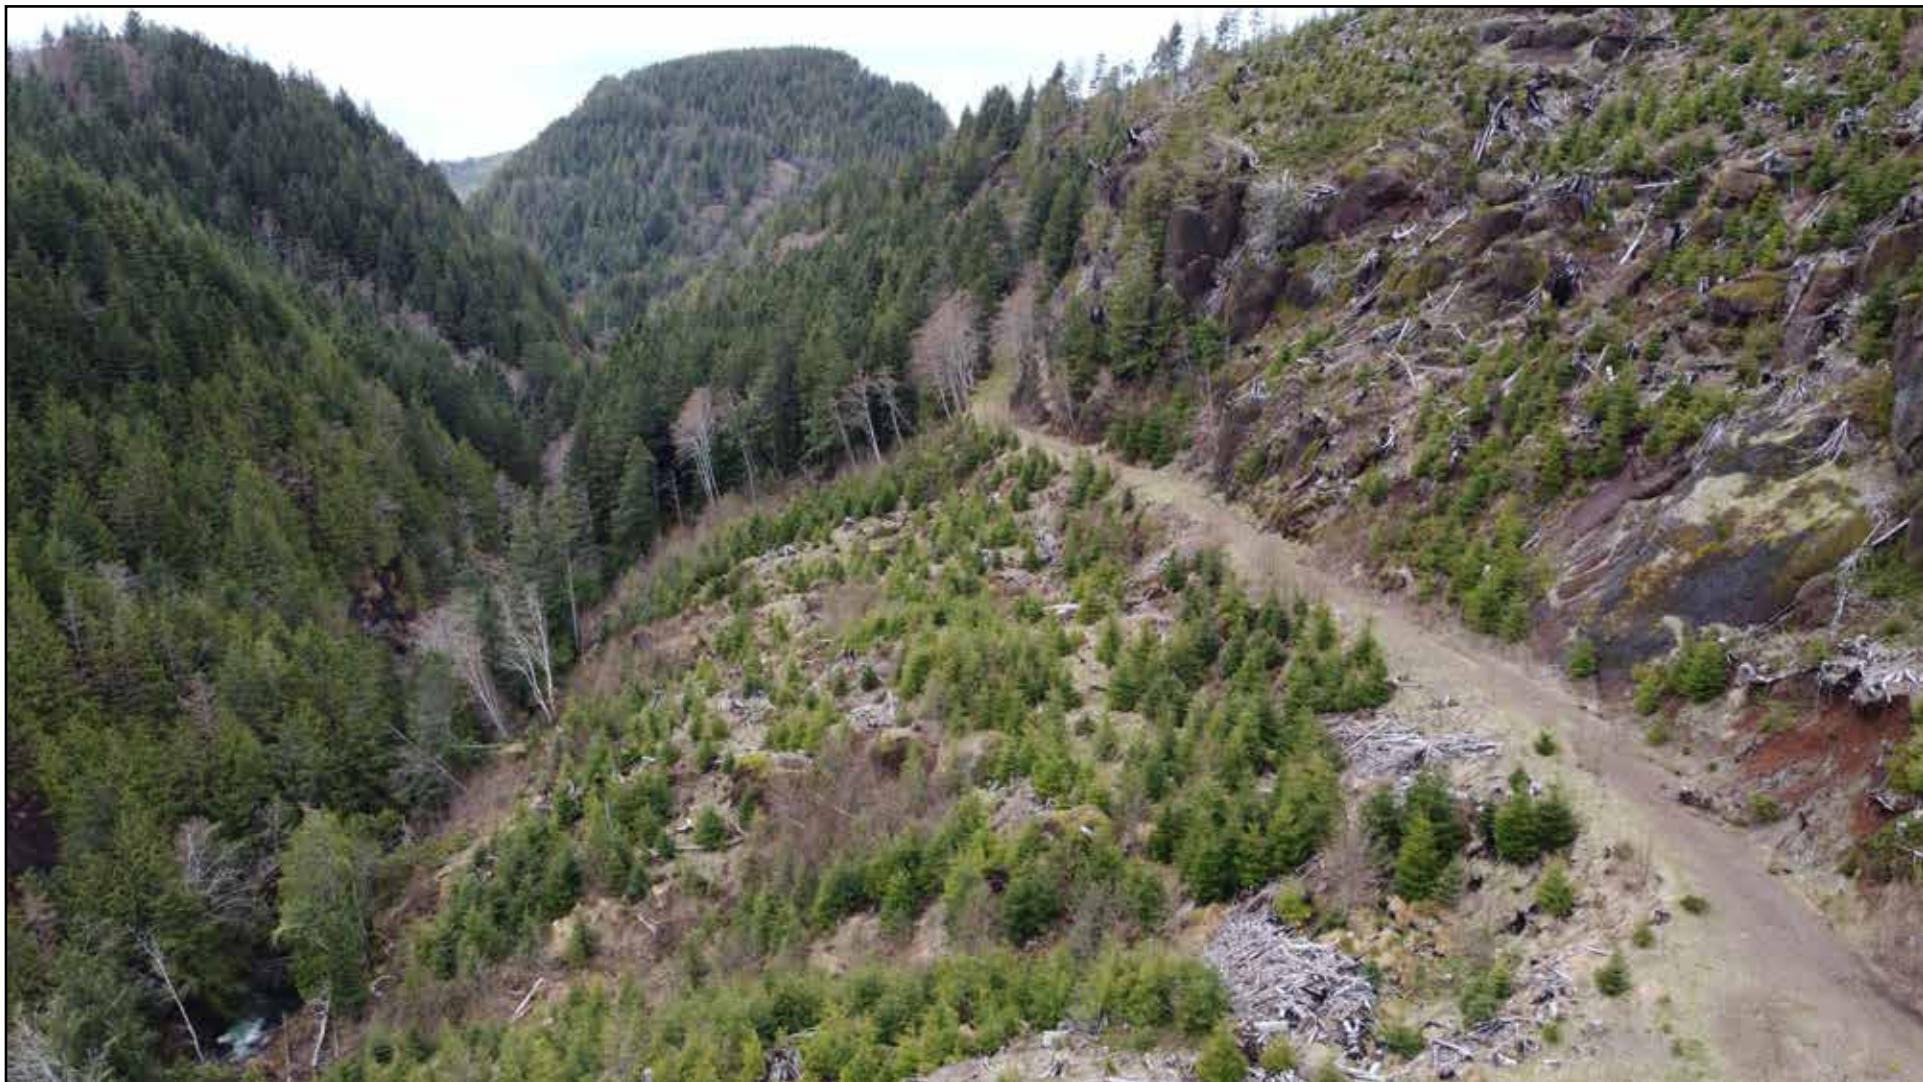
Segment 65

The Shingle Mill XO Road continues up Shingle Mill Creek after it crosses a landslide. The landslide completely closes the road and appears to have continued movement. Above this point, the road is in better condition, having been used more recently. The road however provides no thru-access at this stage and, as with the lower segment, has some potential of future, significant and costly failure. This road continues up Shingle Mill Creek with numerous culverts in varying states of function.

Management Recommendations: It is recommended, as with the lower segment, to decommission this road. It is a mid-slope road in a sensitive drainage with numerous active landslides throughout the slope, as well as seeps. Decommissioning would require removal of culverts, filling ditches, breaking apart the road surface, and outsloping or providing water bars.

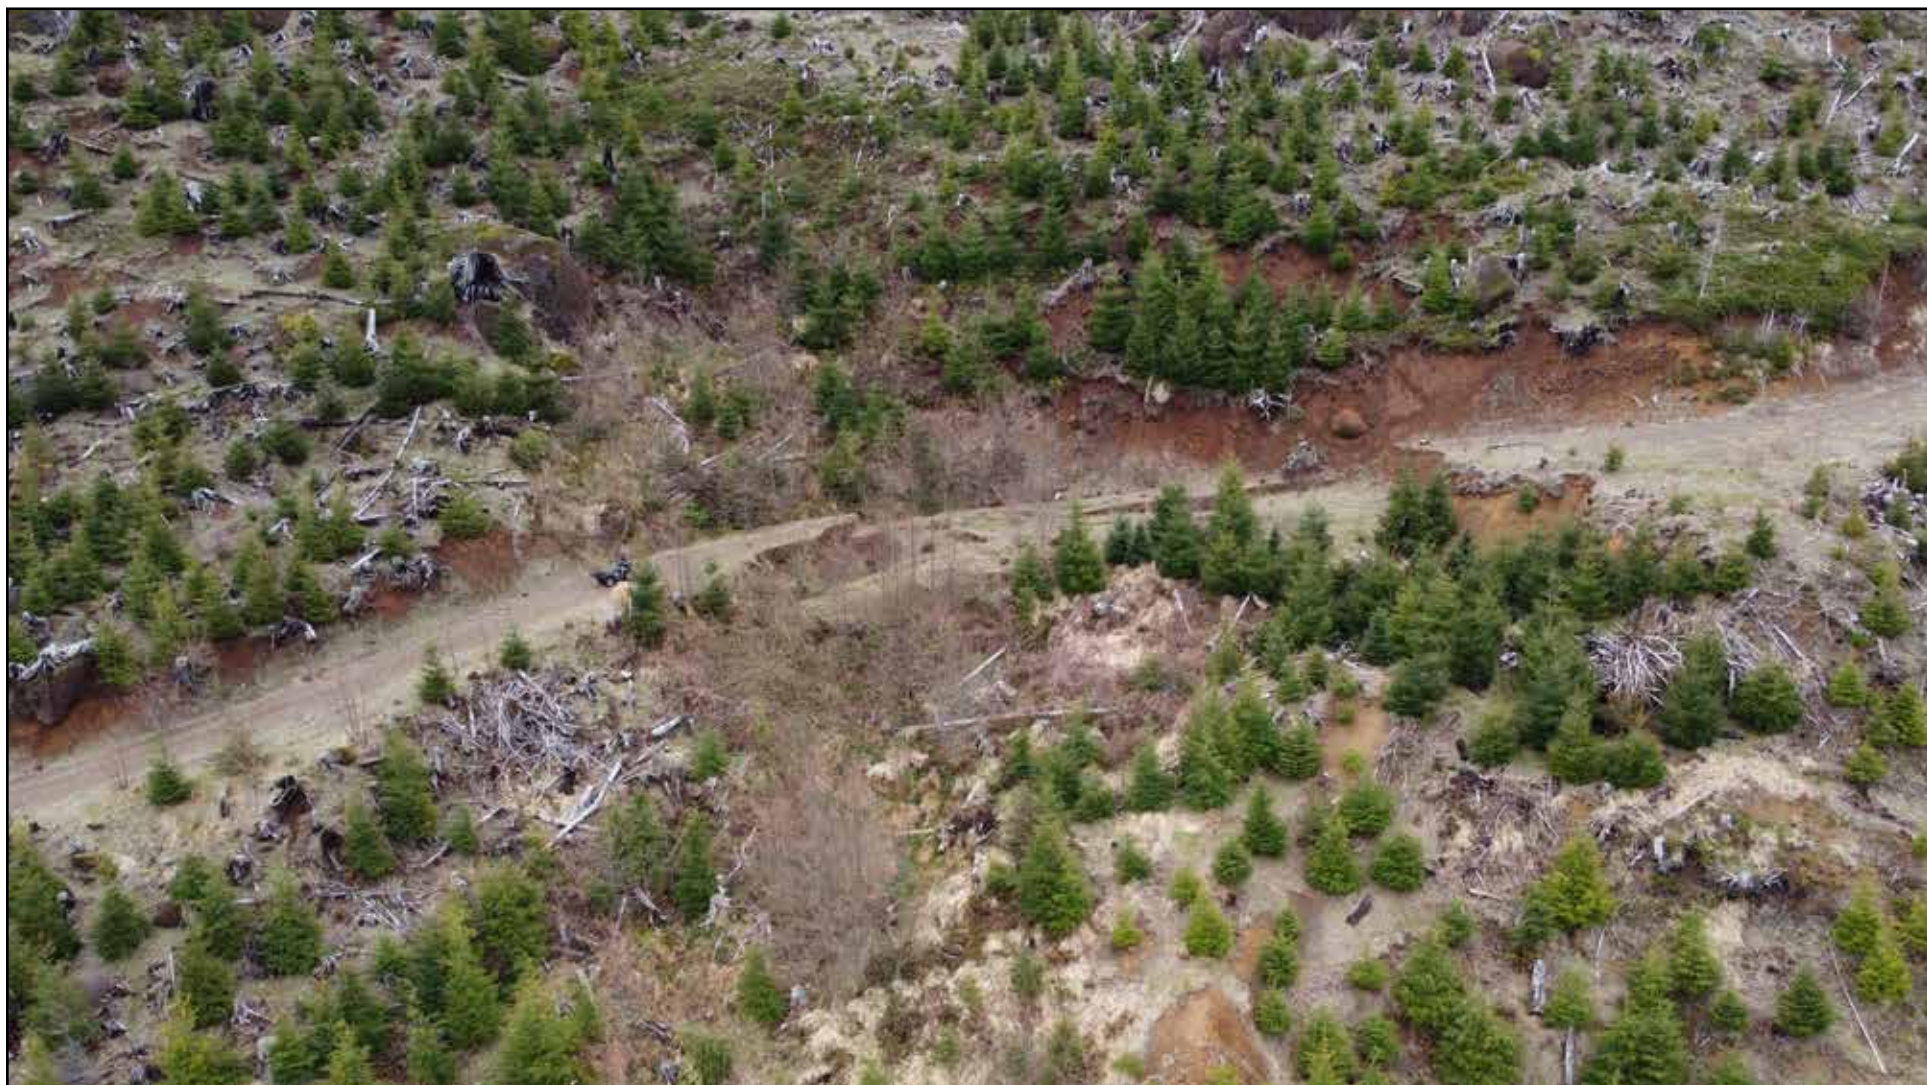
Segment 66

SM 80 is a short spur that historically accessed the N face of Angora Peak. The lower segment and crossing were removed some time ago. There are however culverts still existing on the S side of Shingle Mill Creek. The damage caused by removing these would be prohibitive. The 958' spur that still exists is overgrown and serves minimal current purpose. At some point this area will likely require PCT, but that could be done from the Hug Point Rd.

Management Recommendations: It is recommended to decommission the 958' of SM 80 spur and continue to abandon the 3809' that is basically inaccessible. Decommissioning would require the removal of 2 culverts and standard excavation.

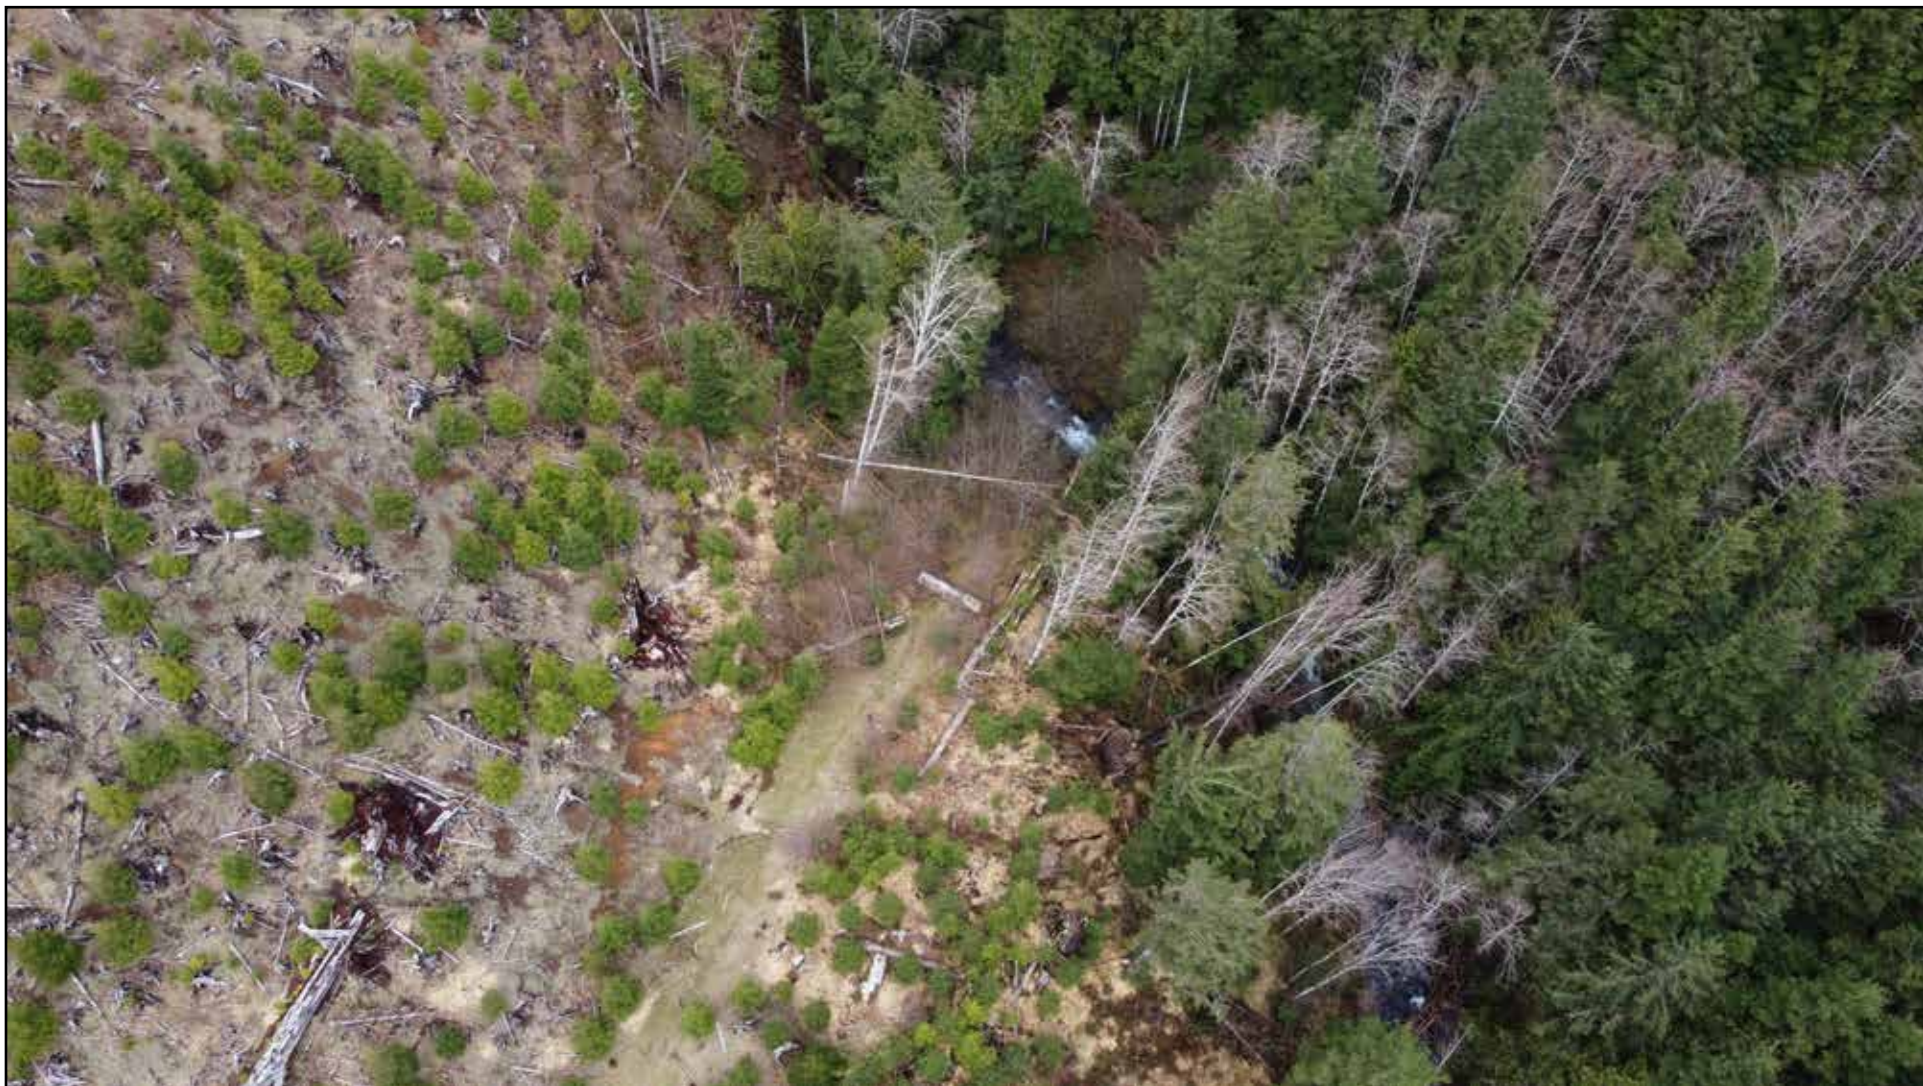
Segment 67

The Hug Point Road provides access to upper Shingle Mill Creek and numerous young stands that may require future management. This segment is rock surfaced with a large boulder directly south of the "knob". The road requires clearing from just past HP27 around the knob, but is currently drivable by the bold or on an ATV.

Management Recommendations: It is recommended to maintain this segment to the Shingle Mill XO. This will require standard brushing and removal of boulders and rip rap from the road surface. The road is quite rough, but does not provide any significant drainage. The end of this road, where it meets the Shingle Mill XO, includes a very strange intersection that would benefit from improved drainage (shown on the following page).

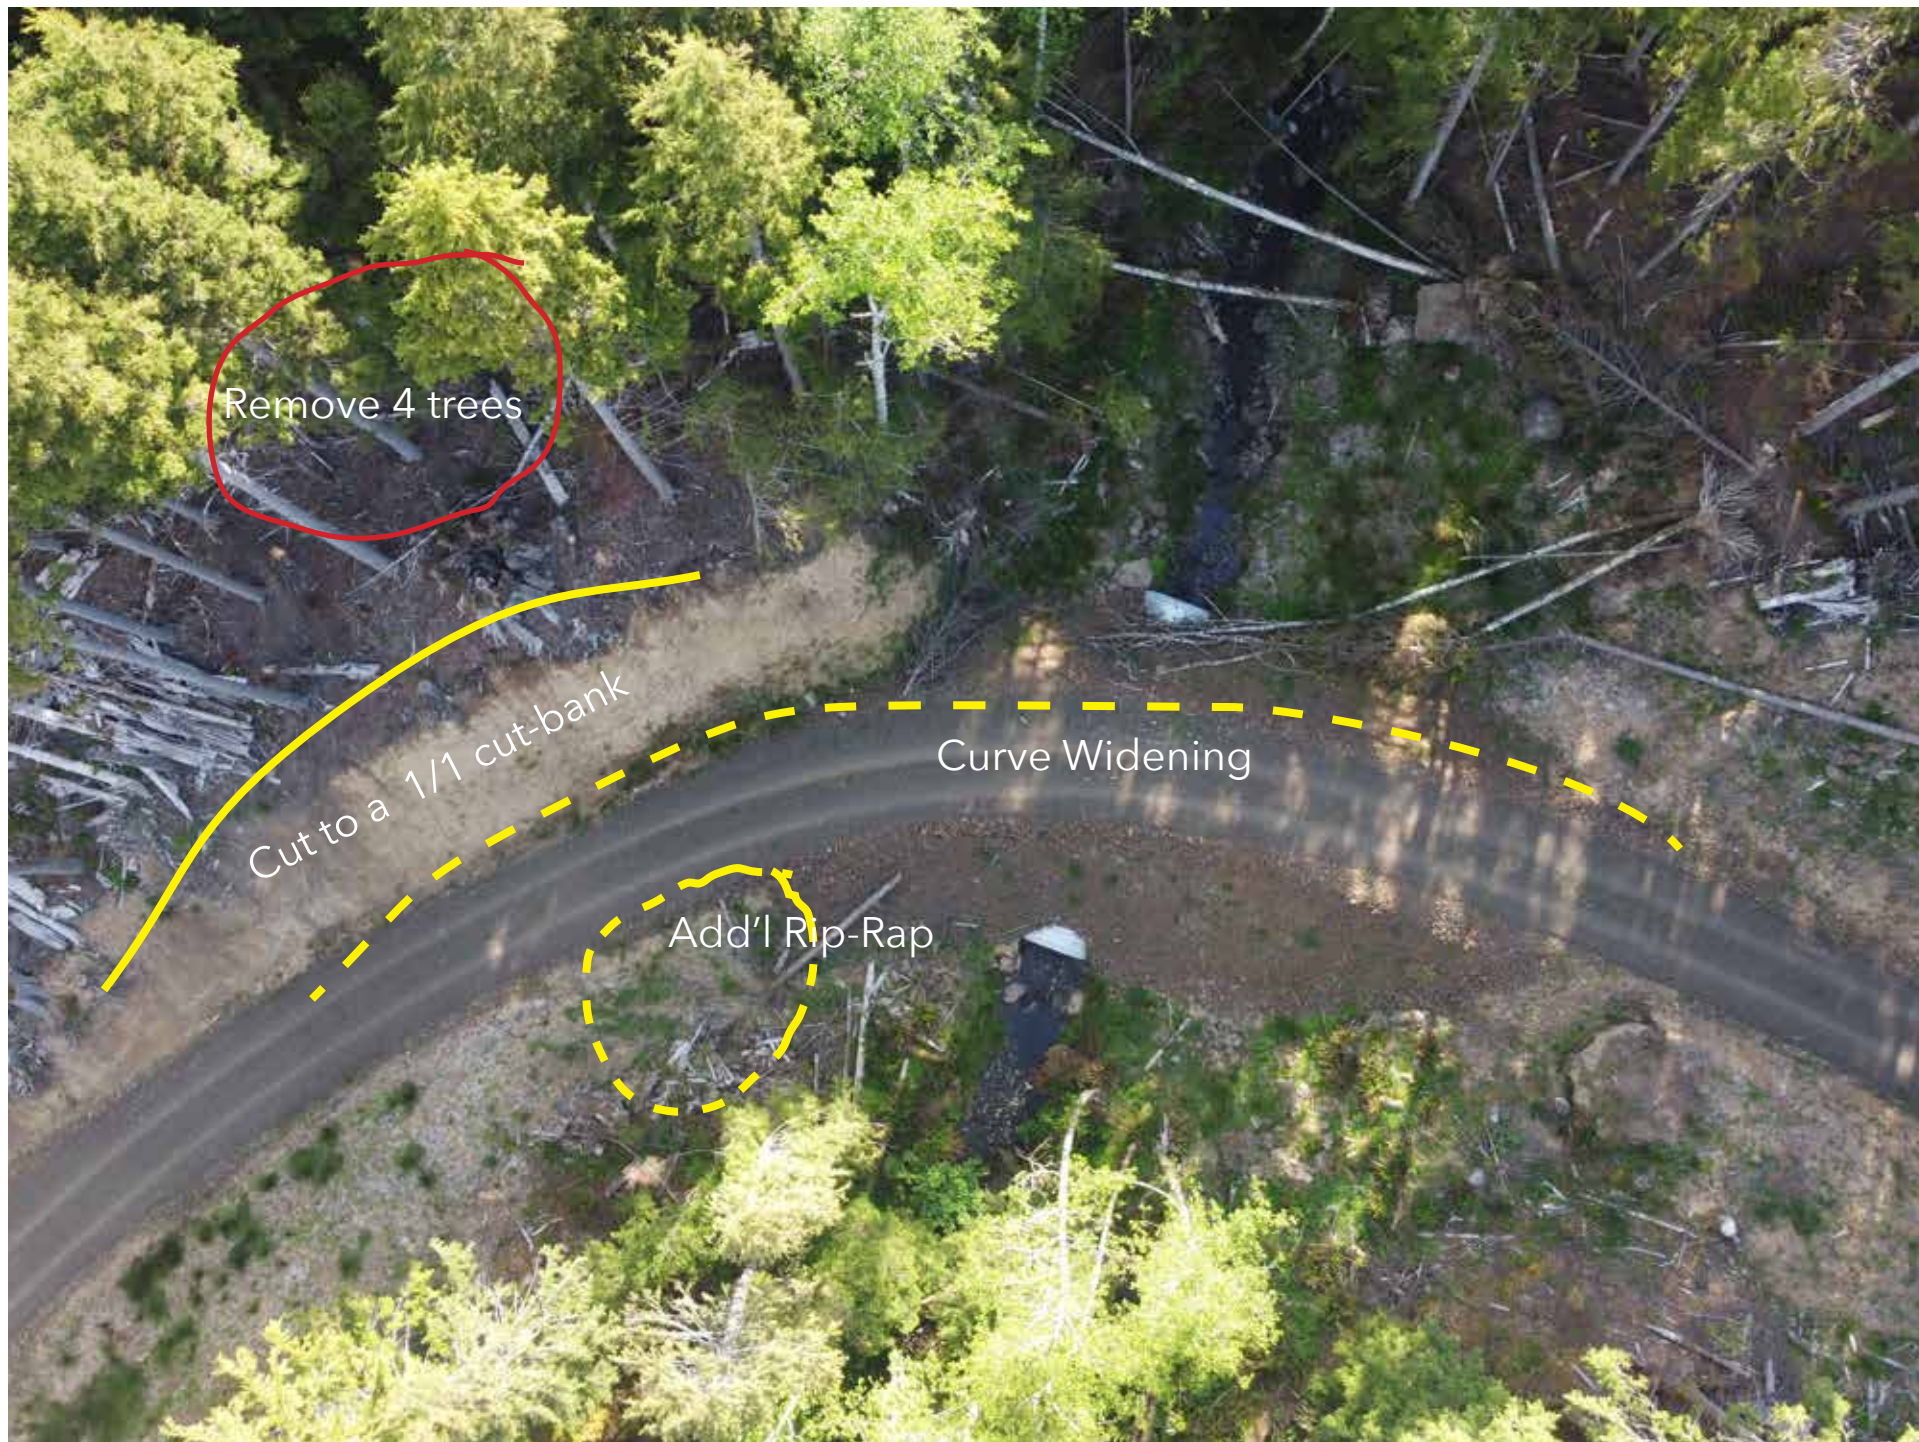
The HP 19 was re-aligned by EFM following a mass soil movement on the original HP19. The re-alignment required a new large stream crossing (Shark Creek, inside the DWSA) and installation with a significant fill. During the construction of this crossing, the contractor hit solid rock and was unable to lower the road surface in order to meet standard specifications for curve widening, fill slope, and road width. The result is a crossing that is borderline passable with a log truck and presents significant erosion risk from overly steep banks. The solution is to either A) widen the curves and reinforce the banks B) remove and re-build the crossing 75' downstream or C) shift access to another road. Option A is recommended, especially if a no-harvest scenario is selected, with plan details on the following pages.

Remove 4 trees

Cut to a 1/1 cut-bank

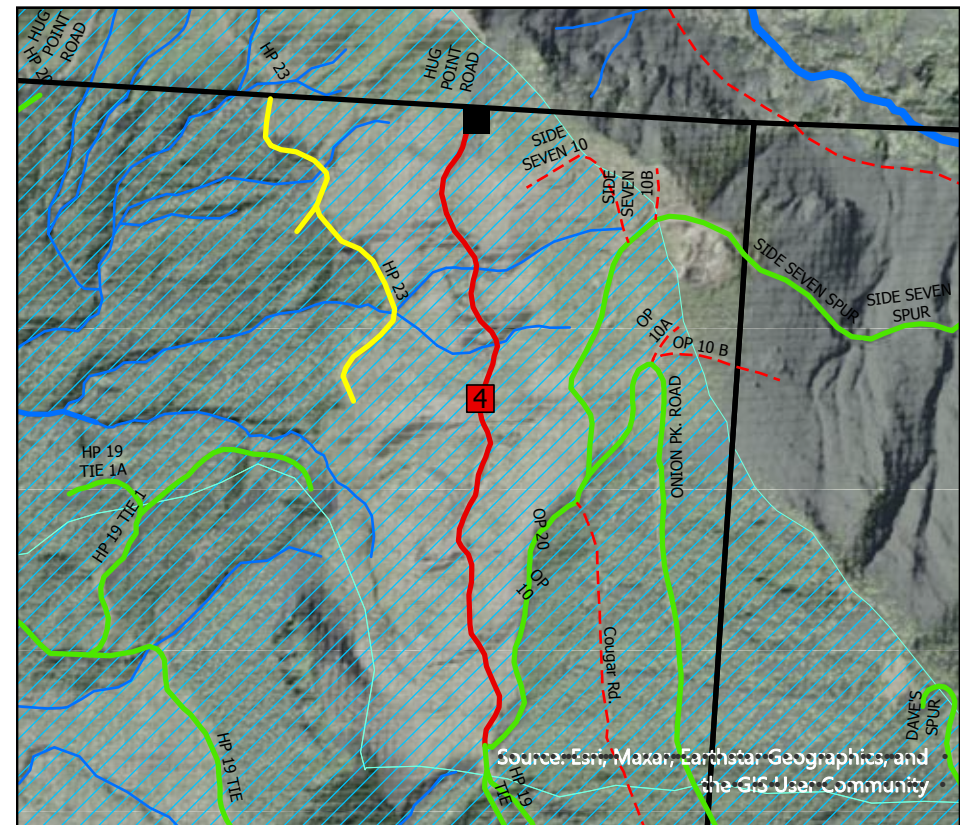
4. HUG POINT ROAD REMOVAL

The Hug Point Road cuts from Lewis and Clark Timberland's boundary due south across the top of the DWSA. This road has been closed since approximately 2016 due to both rock-fall onto the road surface and slumps on headwall road fills. The road no longer serves any access purpose, and presents both risk of catastrophic failure and for vehicular access (it has continued to receive some use despite very clear signage and a gate). ODF fire personnel indicated that they would have sufficient access without this road, and that it presents something of an access risk for vehicles without local familiarity.

It is recommended to fully remove the entirety of the road from the junction on Lewis and Clark Timberland and the OP junction. This requires the removal of 12 culverts, crunching the road surface, and placing downslope road-fill into the cut-bank / ditch. This exceeds the decommissioning called for elsewhere in the plan. The site would be re-vegetated following the project.

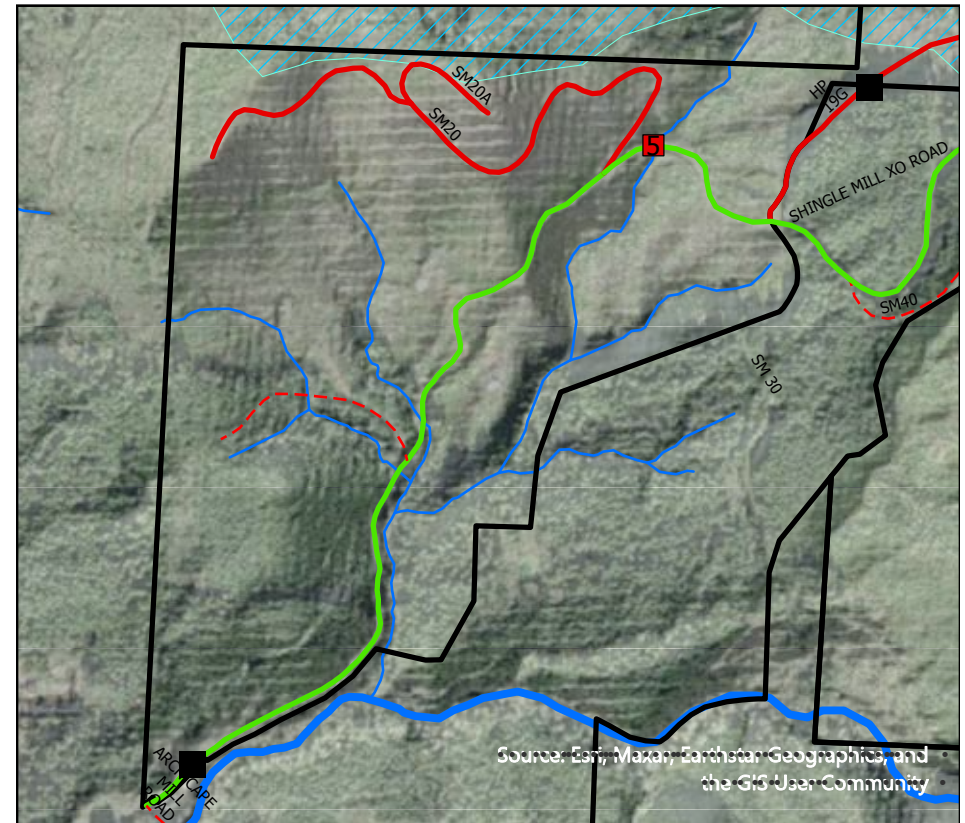
5. SHINGLE MILL XO REPAIR

The road is potholed with standing water in the road surface. In addition, the two steep grades are eroding rapidly and require a significant lift as well as ditch-outs and other drainage improvements. The entire road is recommended to receive a 6" lift with sufficient rock for curve widening on a 12' running surface.
