Rainforest Reserve and Arch Cape Forest
Ecological Road Assessment

Completed by Springboard Forestry LLC
Client: North Coast Land Conservancy
7/7/2023

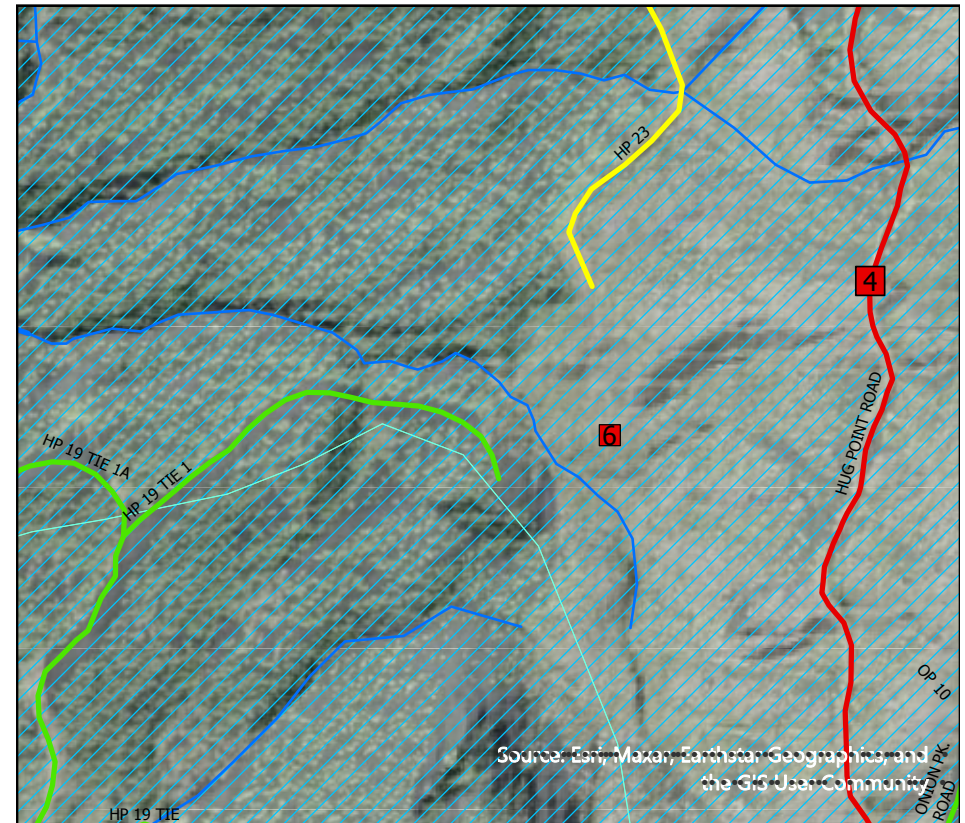
6. HP 23 / 19 TIE (possible)

While primary property access is currently provided by the HP19, the Shark Creek Crossing will likely create continued issues both for vehicle access and for sediment runoff from the steep banks and exposed mineral soil. An alternative is to construct a tie road between the HP19 TIE and the HP23 roads. The straight line distance between the roads is 505', while the new road construction would be approximately 1,500'. The primary advantage would be that the new stream crossing would be on a small non-fish stream rather than the current crossing of a medium fish stream in the core of the DWSA. This option would also require that the ACF, NCLC, and possibly Weyerhaeuser agree to abandon the current access, which has a legal easement, and negotiate a new access easement with Nuveen, the manager of Lewis and Clark Timberlands. This access would be essential to the feasibility of the project.

One other variable is that the curve from the HP19 and initial curve could be difficult to construct for truck traffic. This curve would provide an adverse haul for loaded log trucks. Since large boulders are known to exist in this area, it will not be known until excavation begins how easy / feasible it would be to re-route the intersection to allow for a gradual increase in grade onto the HP19TIE.

Due to these variable costs and complications, it is recommended to only consider the HP23 / 19 TIE if considerable commercial harvest is planned for the property. If this were to take place in the future, this project could be re-considered.
